# Inspection Report

**Property Address:**  
1708 Merriam Dr.  
Bridgewater NJ 08807

## Garden State Home Inspectors, LLC

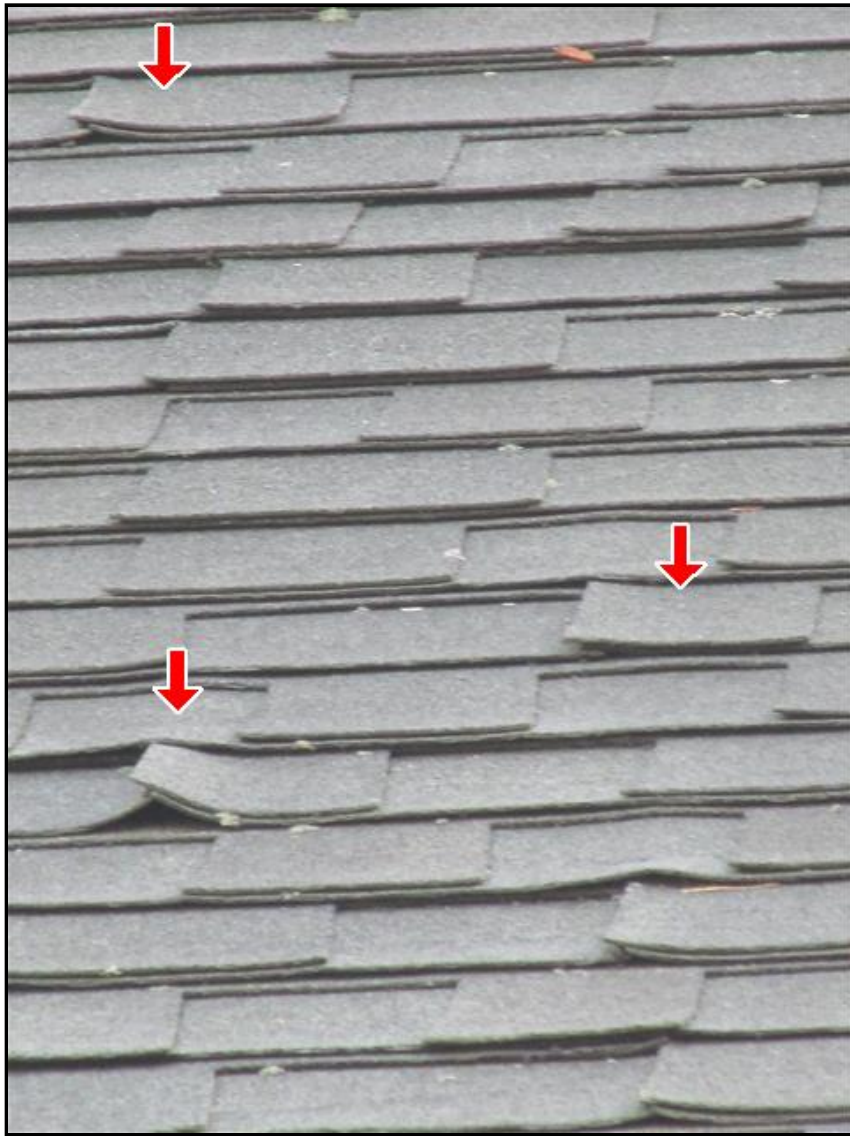
**1.0** The roof covering is failing and is nearing the end of its life cycle at the "entire roof". Roof covering will need replacing before 5 years. A qualified contractor should inspect and repair as needed.

1.0 Item 1(Picture) Aged roofing, repairs / replacement needed.

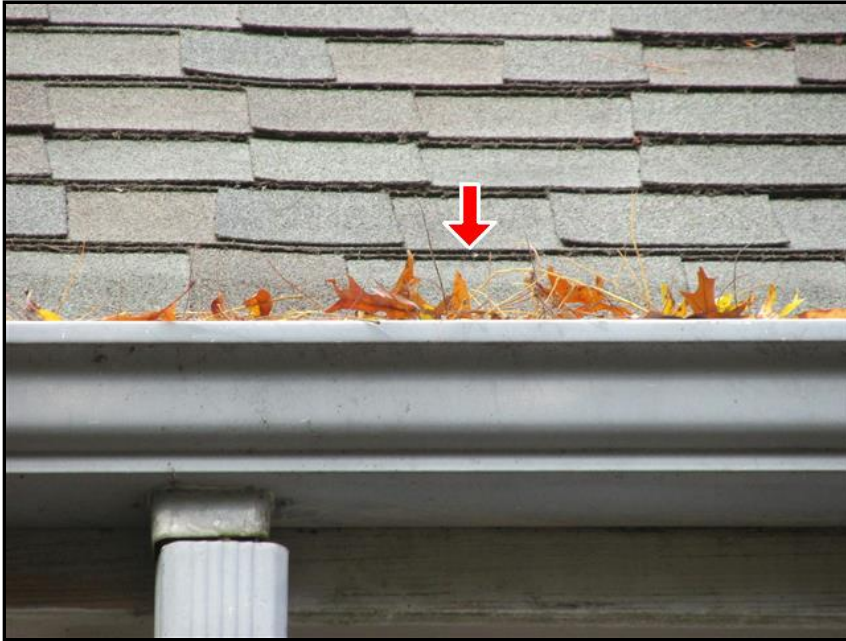
1.3 (1) The gutters are full of debris in areas and needs to be cleaned. The debris in gutters can also conceal rust, deterioration or leaks that are not visible until cleaned, and I am unable to determine if such

1.3 Item 1(Picture) Gutters need cleaning.

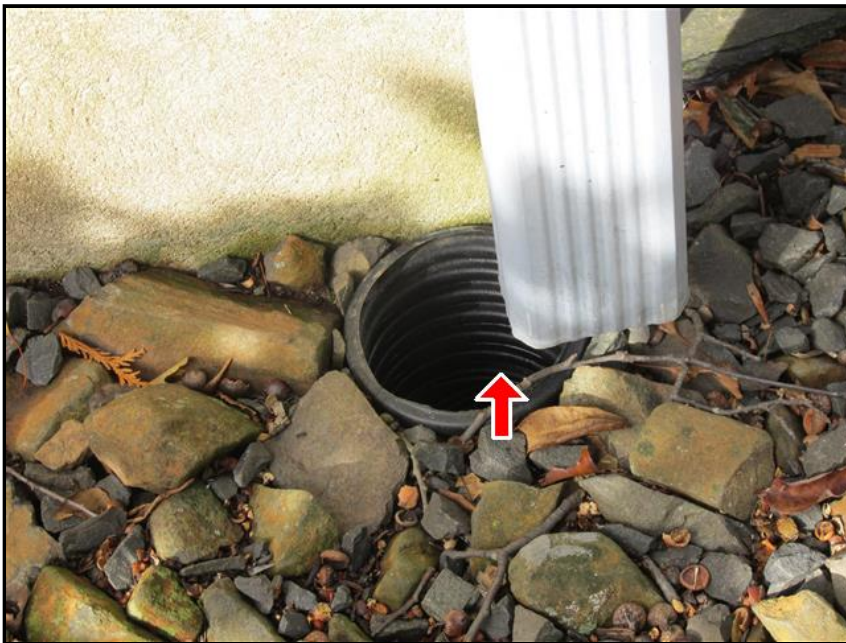
(2) The downspout needs reconnecting to existing drain line at most underground pipe connections. Erosion can continue or become worse if not corrected. A qualified person should repair or replace as needed.

1.3 Item 2(Picture) Downspout connection repairs needed.

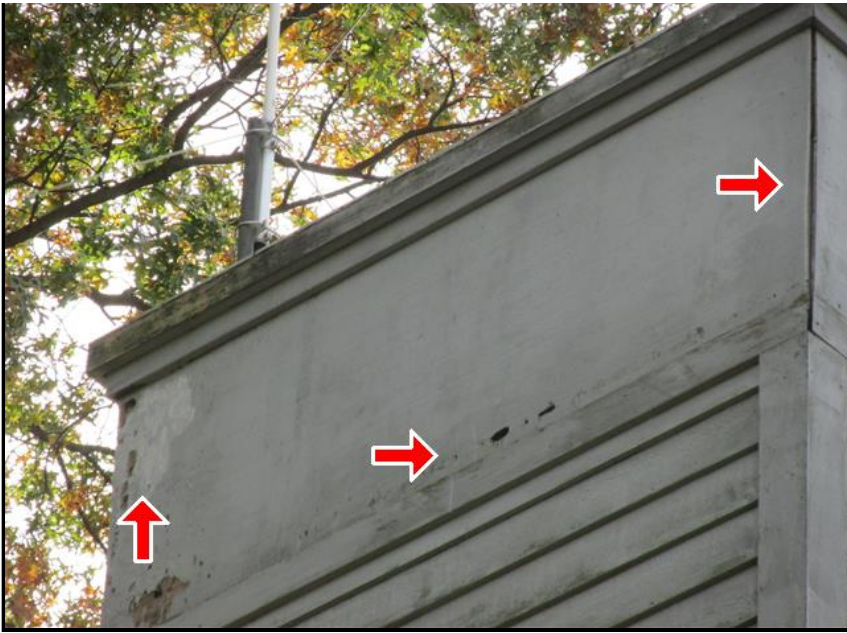
2.0 (1) The Wood siding at the exterior in areas has peeling paint or failing. Deterioration can eventually occur if not corrected. I recommend prep and paint using a qualified contractor.

2.0 Item 1(Picture) Loose, damaged siding.

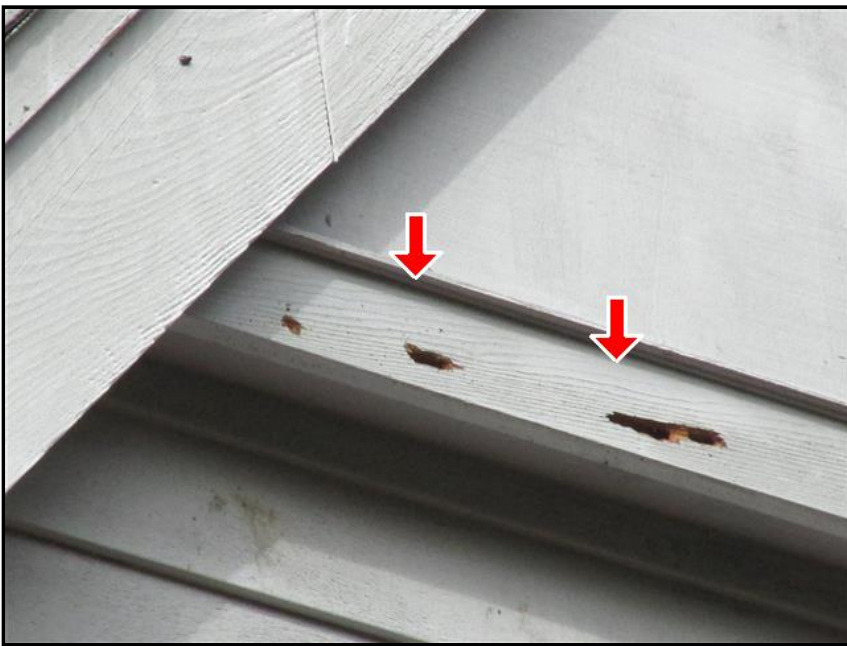
(2) The Wood trim at the exterior in areas is damaged and has peeling paint or failing. Further deterioration can occur if not corrected. A qualified contractor should inspect and repair as needed.

2.0 Item 2(Picture) Damaged trim work.

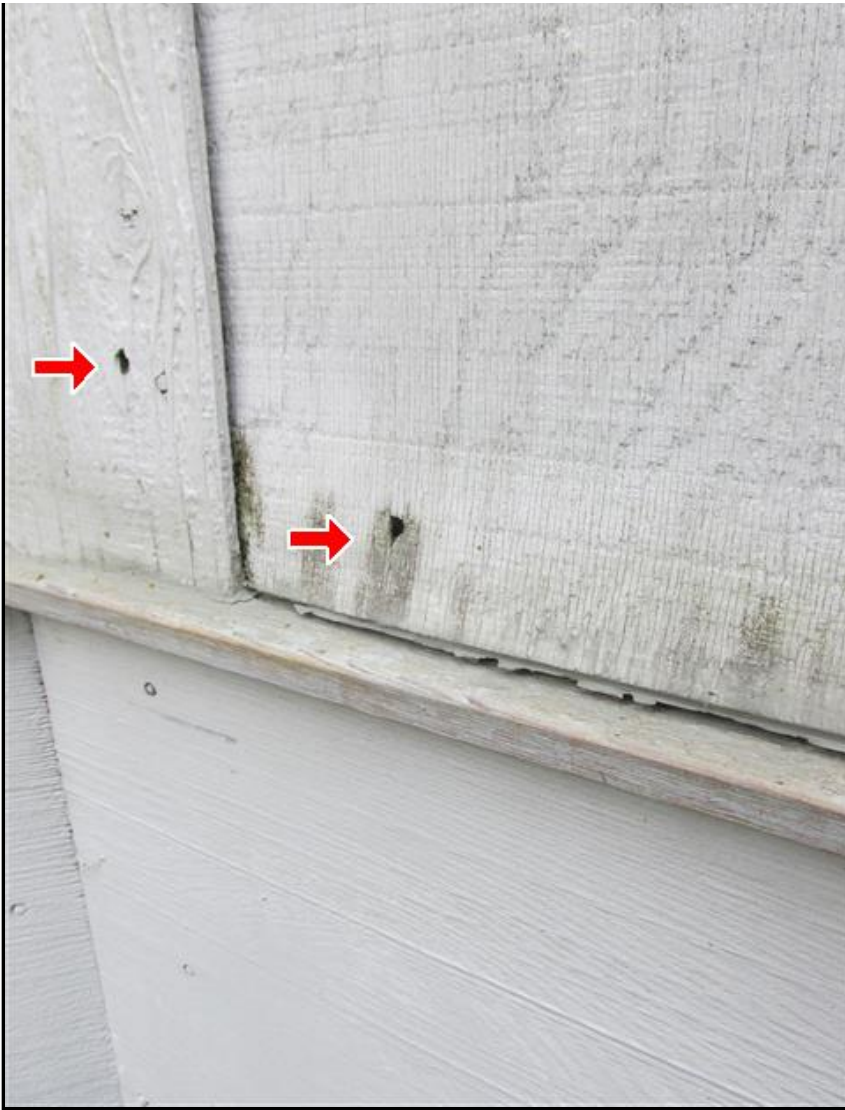
(3) The Wood siding at the exterior in areas has lifted nails and needs tightened. Further warping of siding can occur if loose nails are not tightened. A qualified contractor should inspect and repair as needed.

2.0 Item 3(Picture) Lifted siding, loose nail heads.

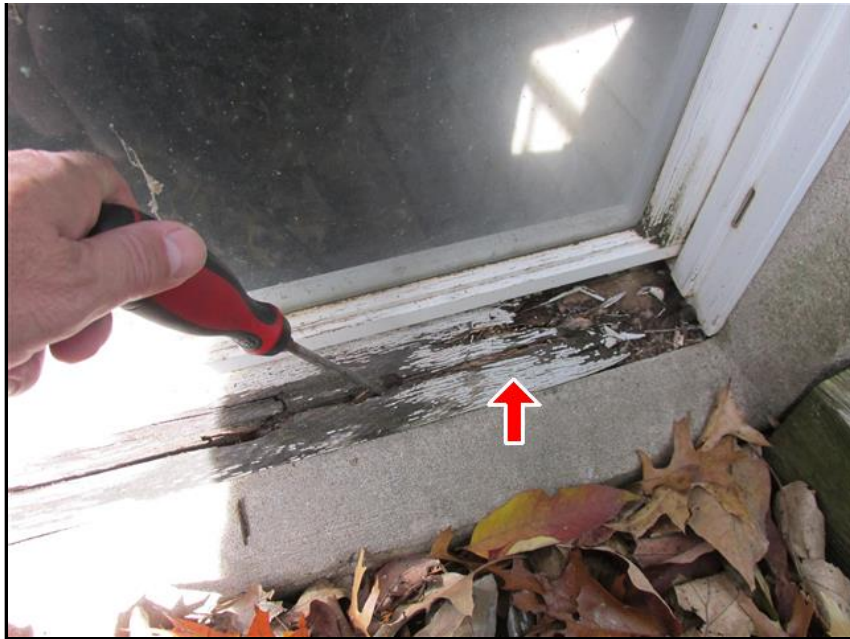
2.2 The basement window frame is insect and water damaged and deteriorated at right side (facing front). Further deterioration may occur if not repaired. A qualified contractor should inspect and repair as needed.

2.2 Item 1(Picture) Deteriorated basement window frame.

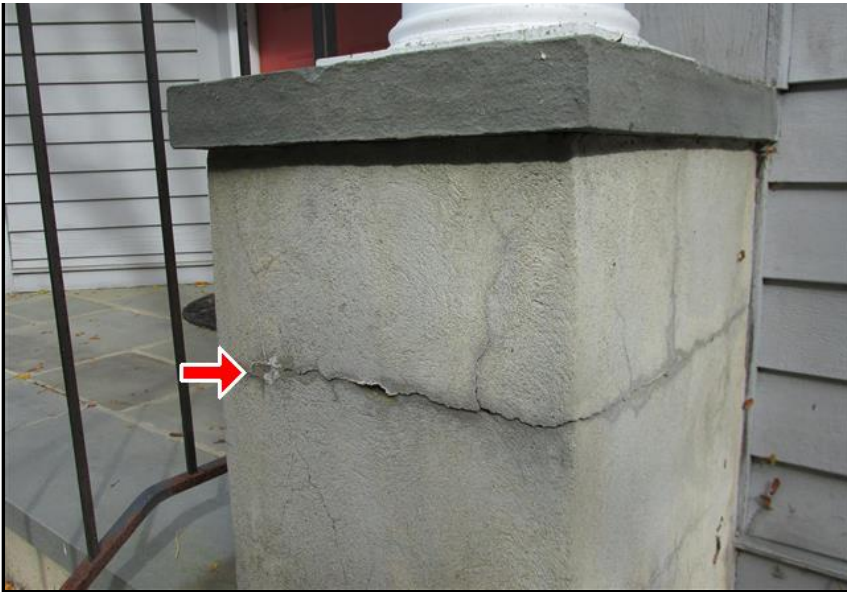
2.3 (1) The stone steps and porch at the front of home needs mortar where loose or missing. Further deterioration can occur if not repaired. A qualified contractor should repair or replace as needed.

2.3 Item 1(Picture) Porch mortar repairs needed.

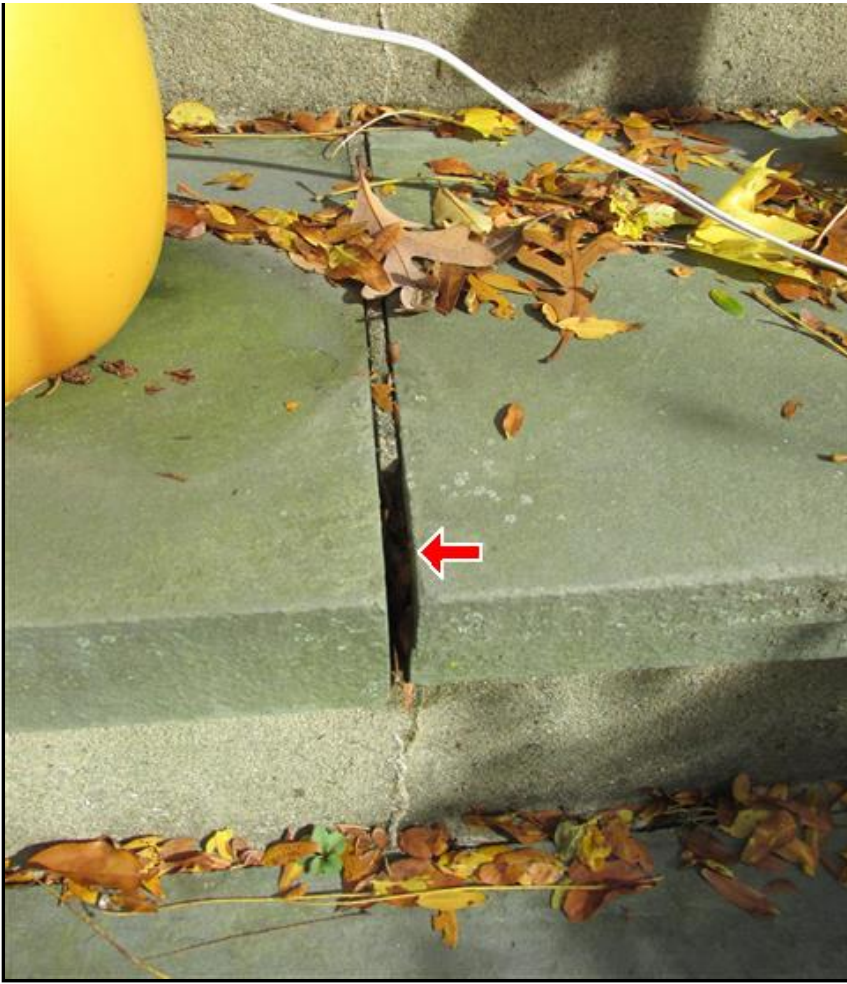
2.3 Item 2(Picture) Porch mortar repairs needed.

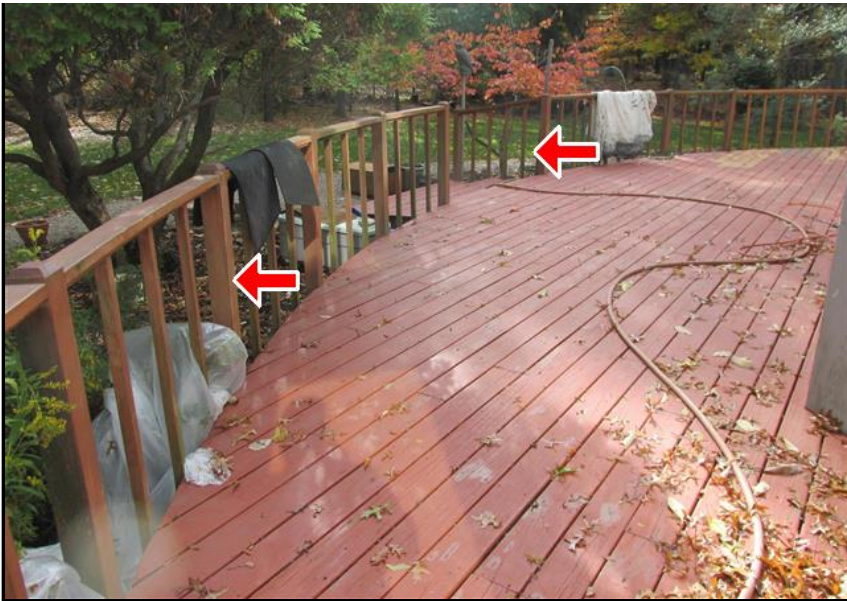
(2) The guardrails on deck at the rear of home and balcony at side of home are spaced to far apart for safety. Spacing more than 4 inches apart could allow an adult, child or pet to fall through. A qualified contractor should repair or replace as needed.

2.3 Item 3(Picture) Deck spindles spaced to far apart.

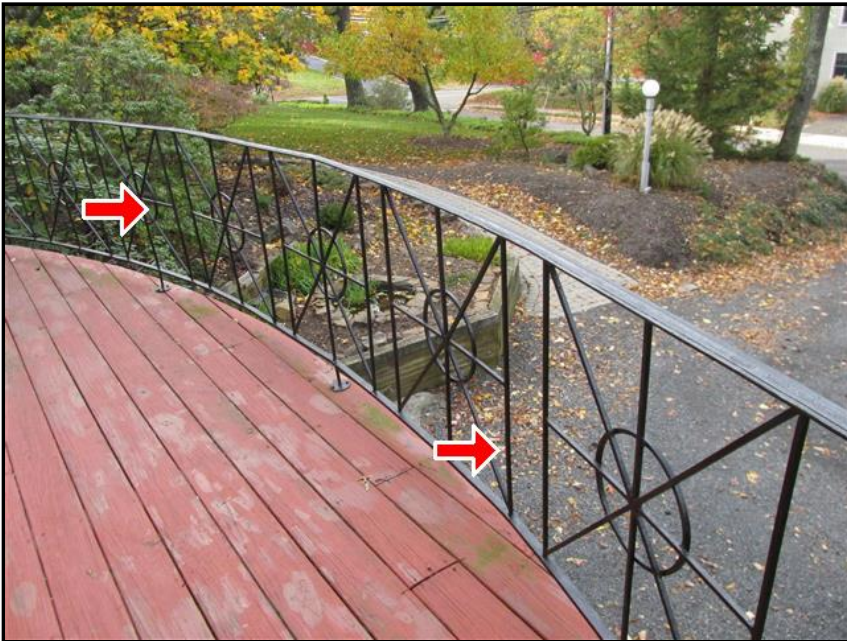
2.3 Item 4(Picture) Balcony railing balusters spaced to far apart.

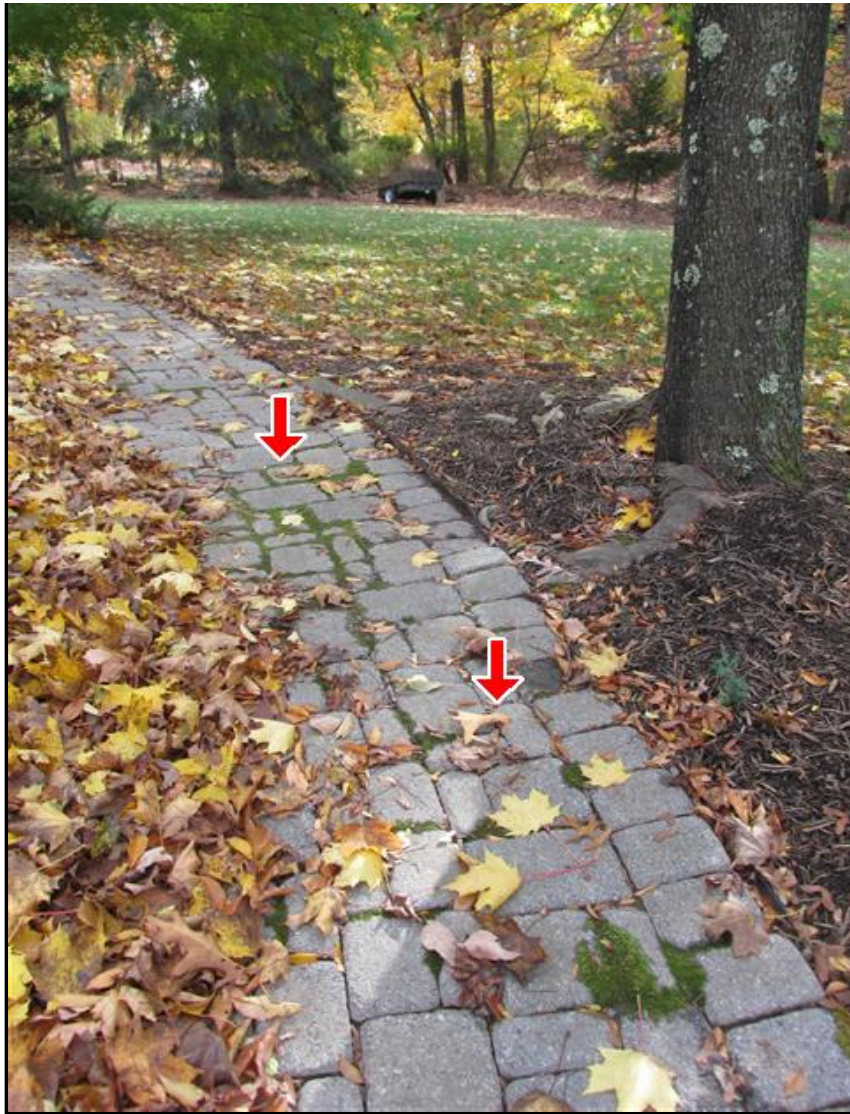
2.4 (1) The brick walkway at the front of home and left side (facing front) has dropped or settled causing a steep or uneven step and shows signs of erosion and problem needs to be addressed. Water can cause further deterioration if not repaired and sealed properly. A qualified contractor should inspect and repair as needed.

2.4 Item 1(Picture) Walkway erosion occurring.

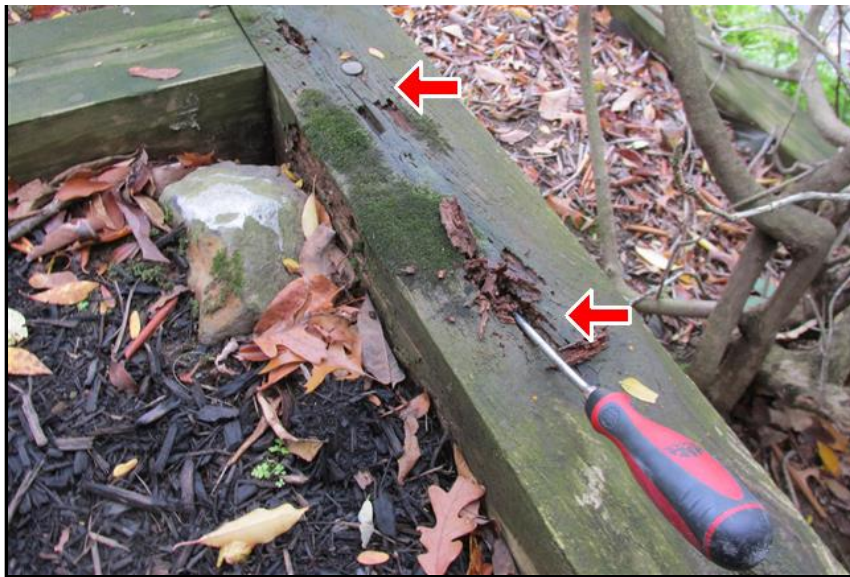
(2) The wood timber wall at the exterior areas shows signs of insect damage, erosion and a possible drainage problem. Further deterioration may occur if not repaired. A qualified contractor should repair or replace as needed.

2.4 Item 2(Picture) Damaged timber walls at small areas.

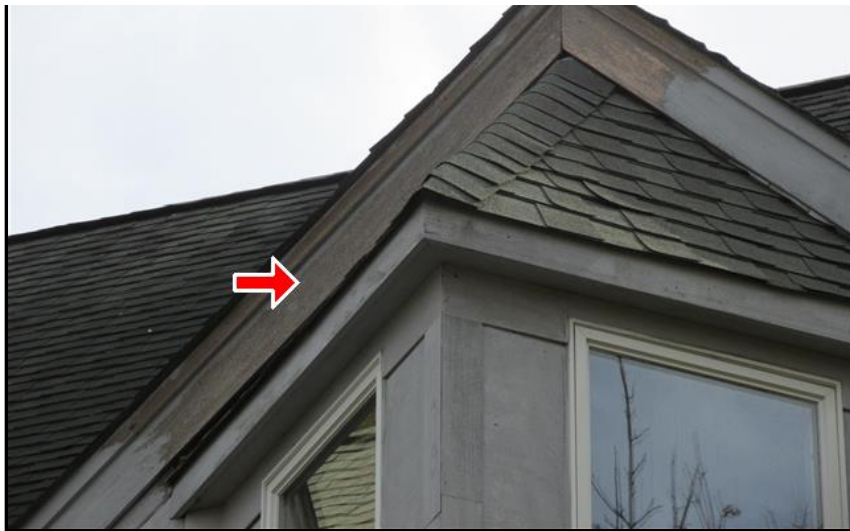
2.5 Item 1(Picture) Prep, prime and paint needed at exterior.

2.5 (1) The wood fascia at eave on the exterior in areas are damaged and has peeling paint. Further deterioration may occur if not repaired. A qualified contractor should inspect and repair as needed.

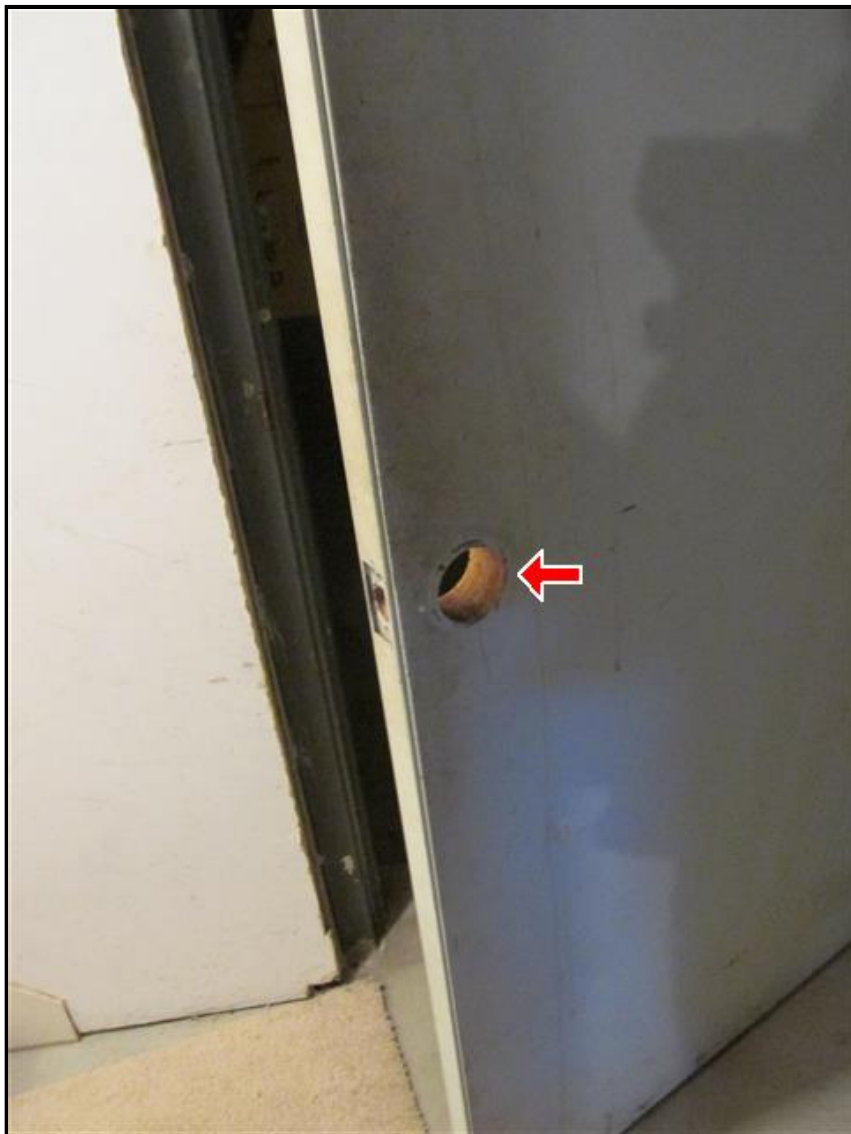
3.4 The knob and hardware is missing. I recommend install as needed.

3.4 Item 1(Picture) Missing garage door handle hardware.

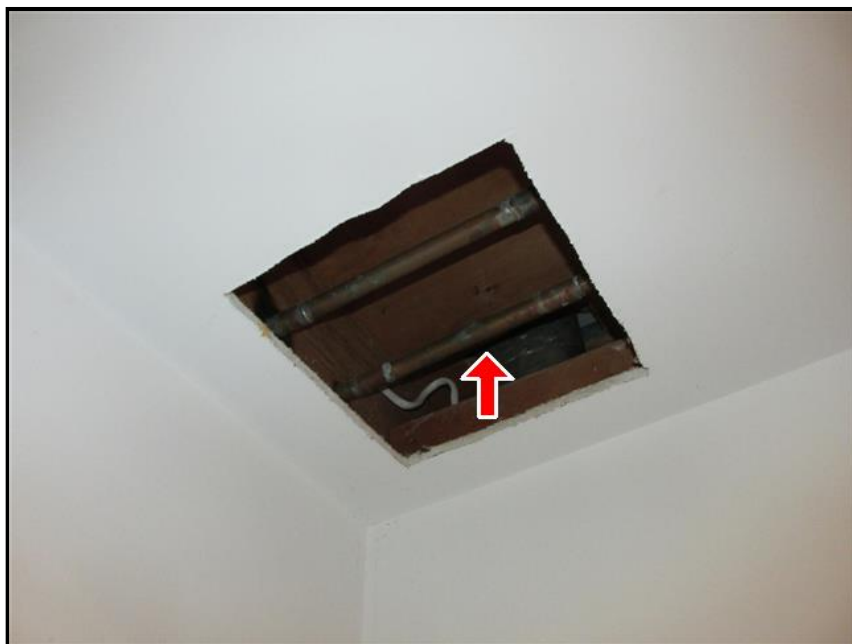
4.0 The Sheetrock on the ceiling is damaged at the downstairs Half 1/2 Bath. While this damage is cosmetic, it needs to be repaired. A qualified person should repair or replace as needed.

4.0 Item 1(Picture) Ceiling sheetrock repair needed.

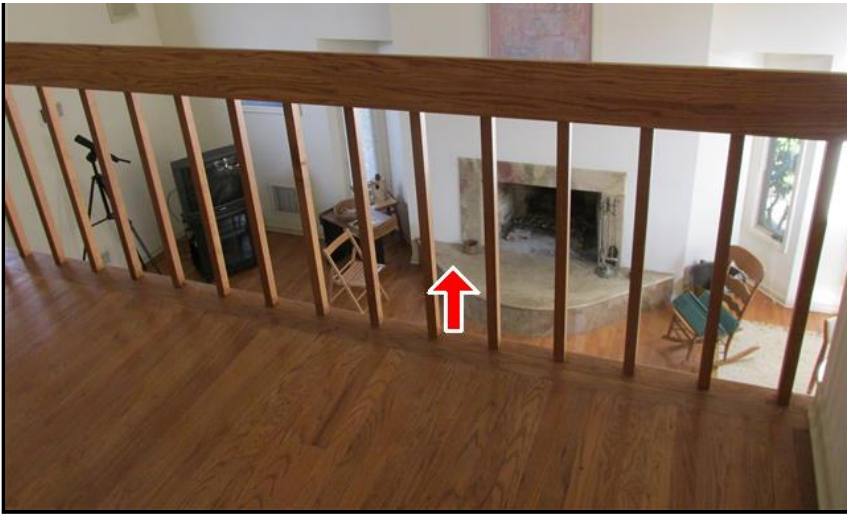
4.3 Item 1(Picture) Spindles spaced to far apart.

4.3 The balusters on the guard rail at the second story stairs are spaced to far apart for safety. Spacing more than 4 inches apart could allow an adult, child or pet to fall through. A qualified contractor should inspect and repair as needed.

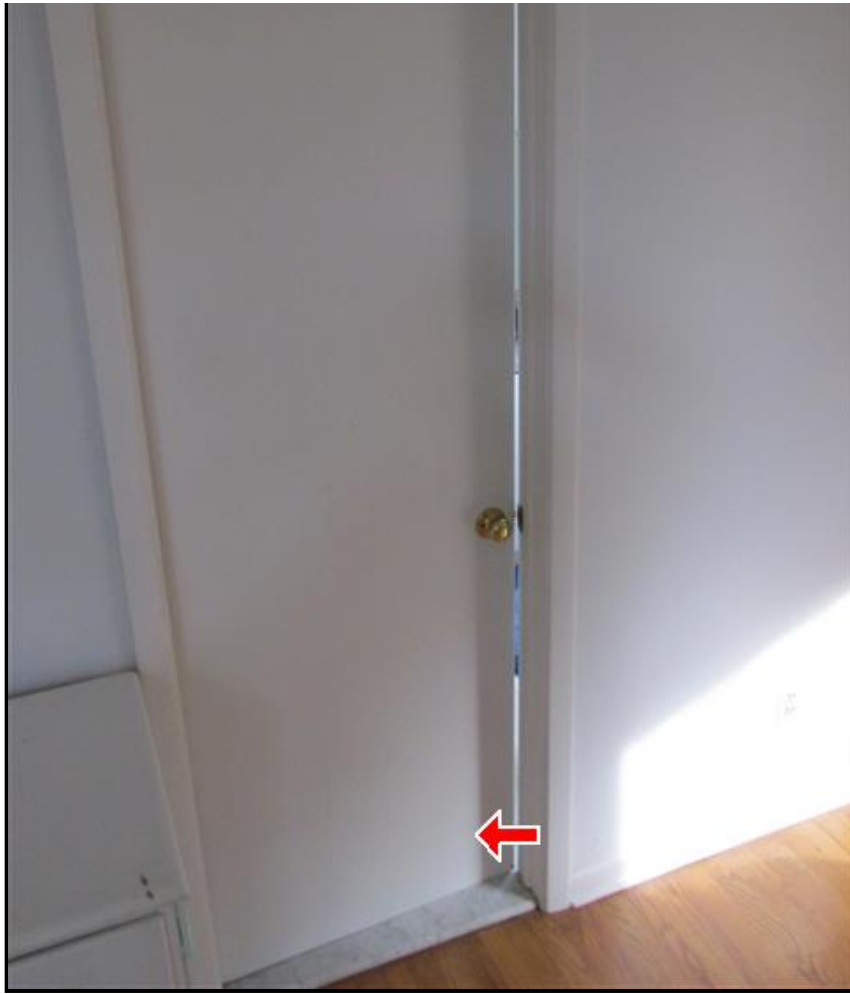
4.5 (1) The Entry door rubs floor when opened. Door needs to be trimmed at bottom by a skilled craftsman and does not lock at the Guest Bedroom Private Bath. A repair or replacement is needed. A qualified person should repair or replace as needed.

4.5 Item 1(Picture) Bath door repair needed.

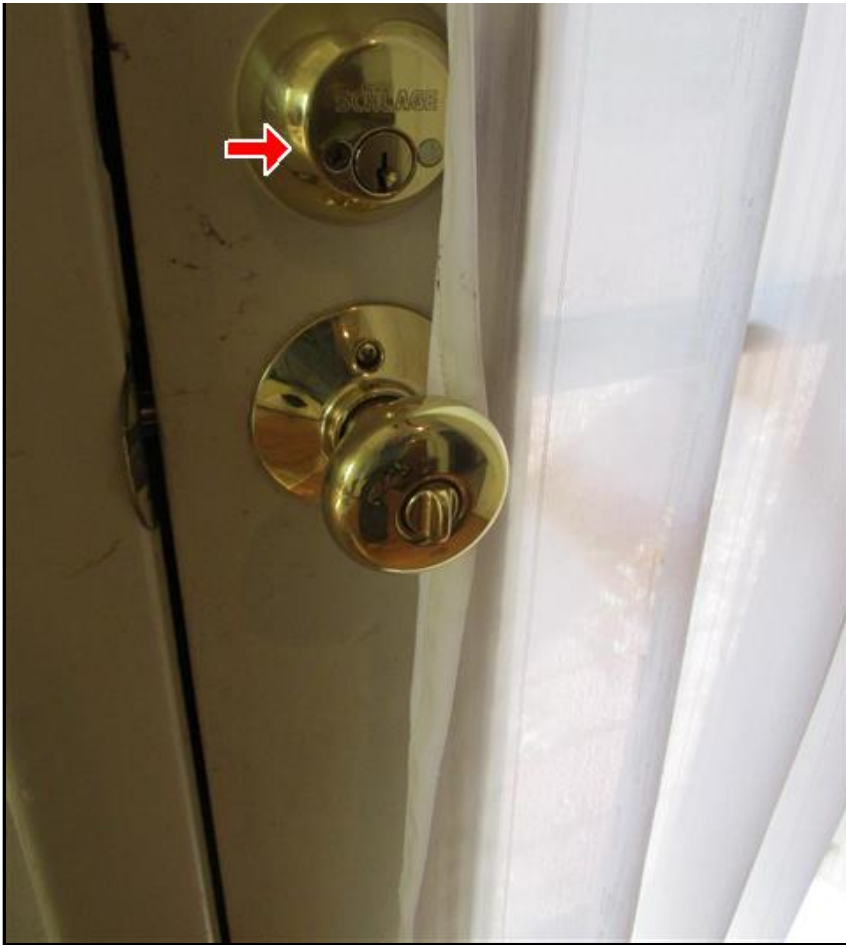
(2) Your home has keyed dead bolt door hardware. This style of hardware is considered a safety issue. I recommend installing knob style dead bolt lock hardware.

#### 4.5 Item 2(Picture) Knob style lock hardware recommended.

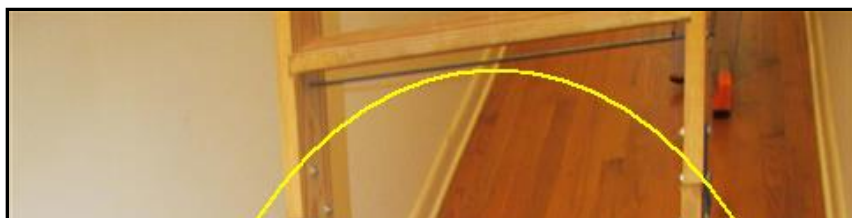
5.5 Item 1(Picture) Attic staircase repairs needed.

5.5 (1) The attic stairs is weak and not stable at or near bottom of stairs. Injury could result if not repaired. A qualified contractor should inspect and repair as needed.

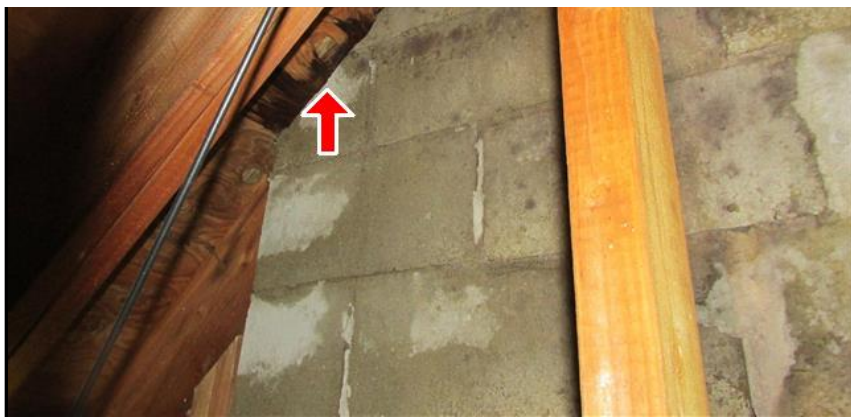
### 5.5 Item 2(Picture) Water intrusion at sheathing around chimney.

(2) The roof sheathing is somewhat deteriorated or soft at the chimney. Water intrusion signs are visible. Repairs are needed. I recommend qualified contractor inspect further and advise for repairs as needed.

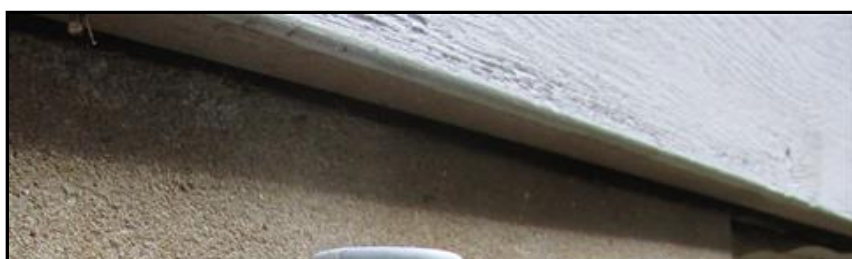
6.1 Item 1(Picture) Hose bib handle leaks.

6.1 (1) The hose bib drips at knob when turned on at the front of home. Repairs are needed. A qualified licensed plumber should repair or correct as needed.

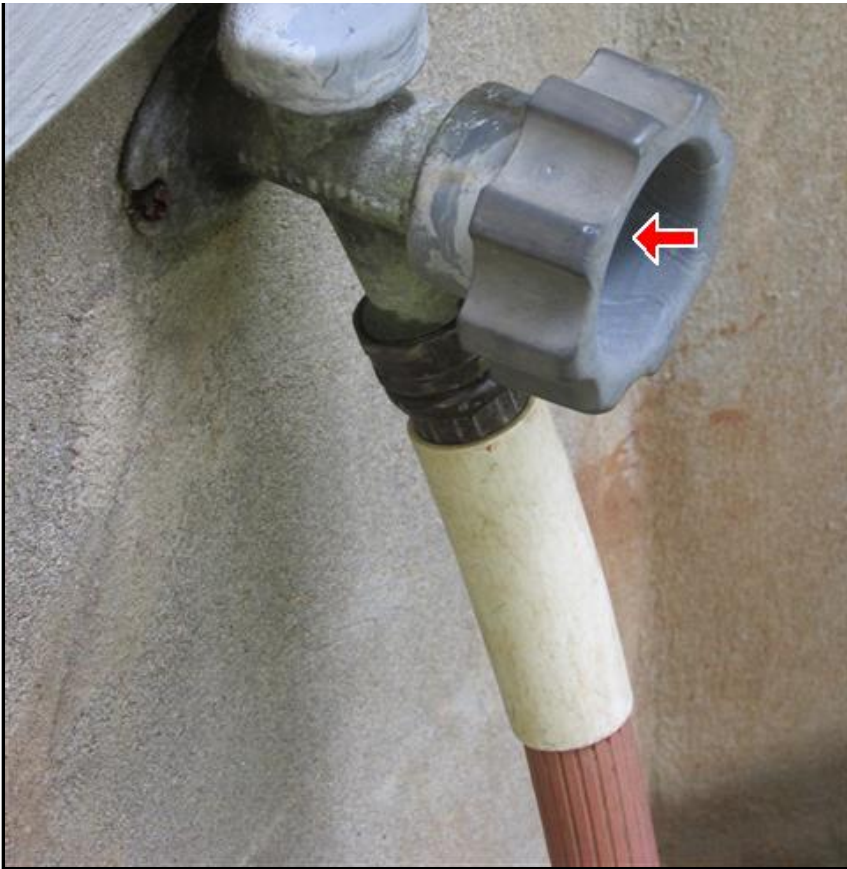
(2) The hose bib did not work at the rear of home. Repairs are needed. A qualified licensed plumber should repair or correct as needed.

6.1 Item 2(Picture) Hose bib handle damaged.

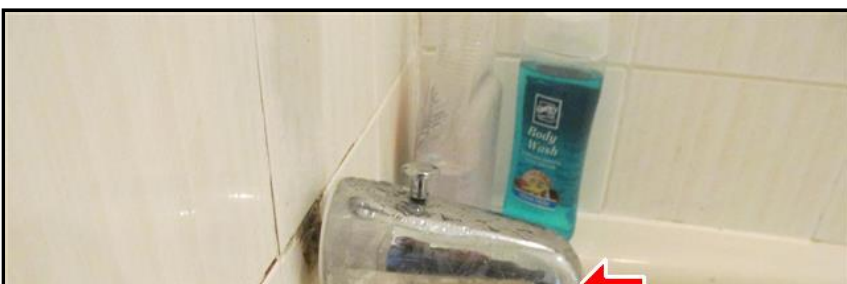
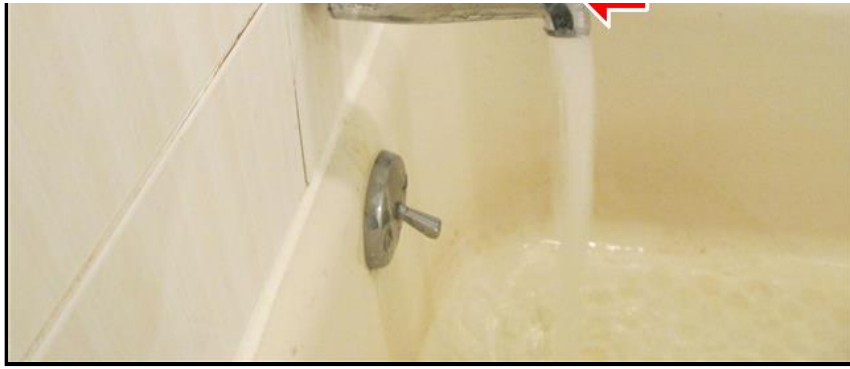
6.1 Item 3(Picture) Spout diverter repairs needed.

(3) The tub spout leaks at the hall bath. Repairs are needed. A qualified licensed plumber should repair or correct as needed.

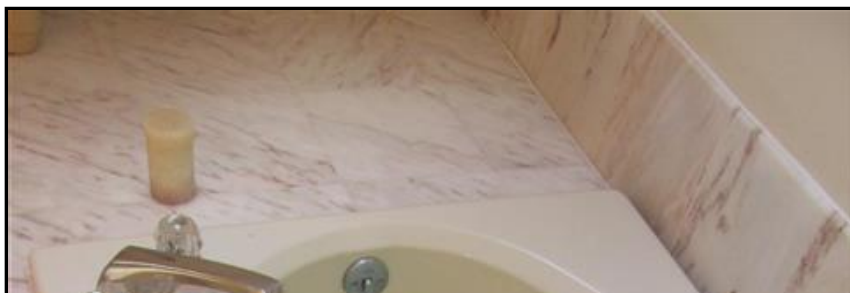
6.1 Item 4(Picture) Jet tub did not function when tested.

(4) The jet powered bath tub did not work properly at time of inspection. I recommend qualified contractor repair as needed.

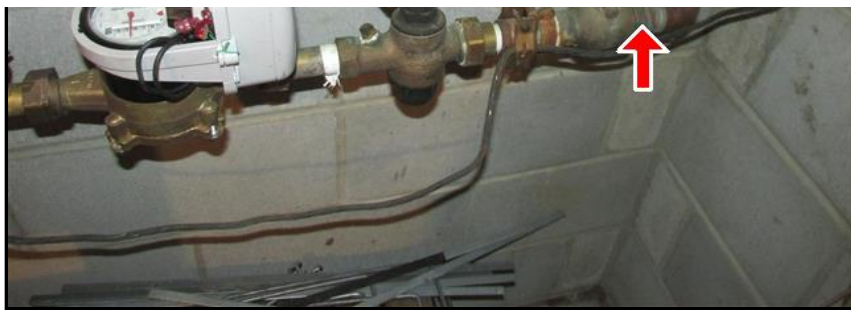
6.3 Item 1(Picture) Main water shut off valve.

6.3 The main shut off is the blue lever located in the basement. This is for your information.

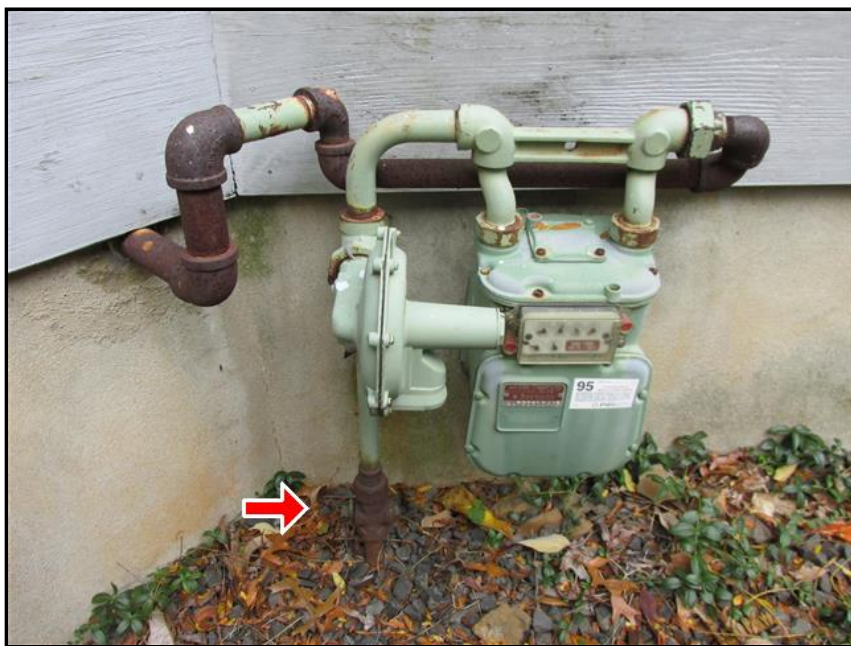
6.5 The main fuel shut off is at gas meter outside

6.5 Item 1(Picture) Main gas shut off valve.

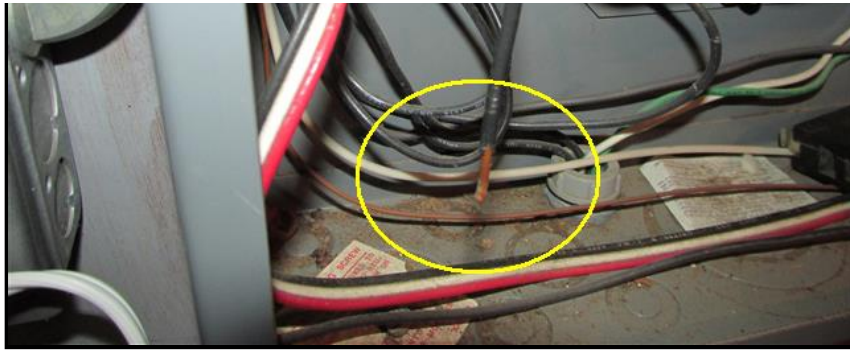
7.1 Item 1(Picture) Open wiring inside electrical panel.

7.1 The problem(s) discovered in the panel such as amateur wiring installation, knock-outs missing on panel and any other problems that an electrical contractor may discover while performing repairs need correcting. I recommend a licensed electrical contractor inspect further and correct as needed.

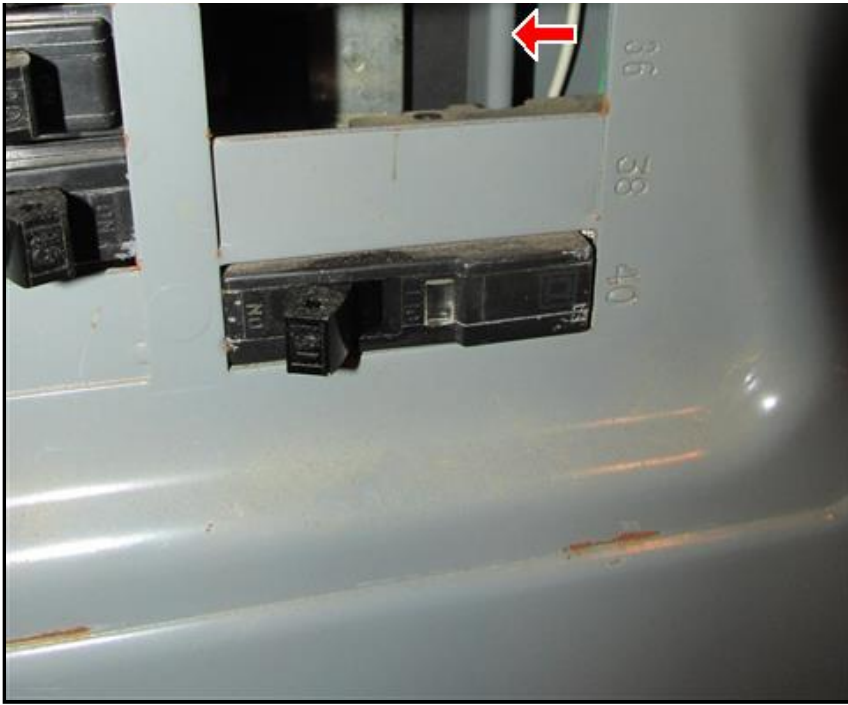
7.1 Item 2(Picture) Missing panel knock out covers.

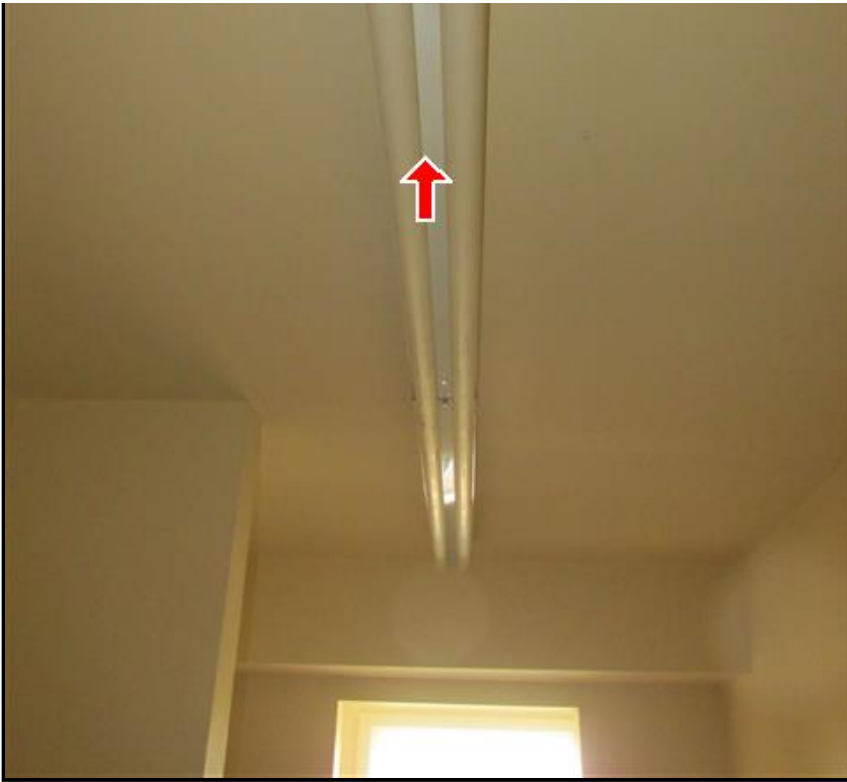
7.3 (1) The light fixture does work, but ballast is noisy at the Master Bedroom closet. Electrical issues are considered a hazard until repaired. A qualified licensed electrical contractor should correct as needed.

7.3 Item 1(Picture) Noisy light fixture ballast.

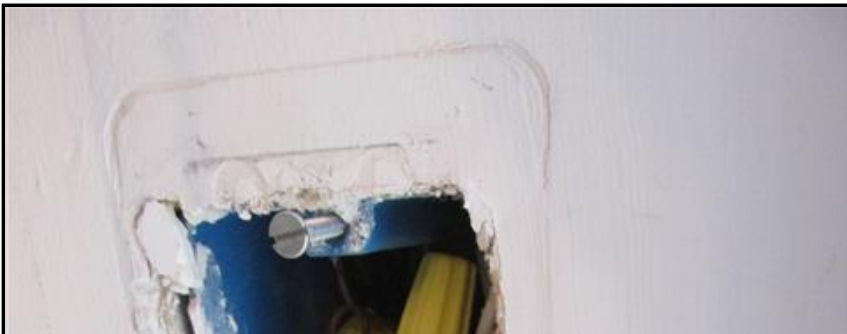
7.3 Item 2(Picture) Missing wall switch.

(2) The wall switch is missing at the Dining Room. Several other outlets and switch plates are missing. Electrical issues are considered a hazard until repaired. A qualified licensed electrical contractor should correct as needed.

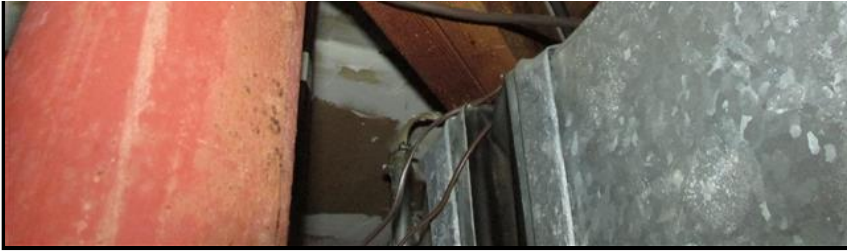
7.3 Item 4(Picture) Missing cover plates.

(3) Several junction boxes and open splices needs placing inside a box with a cover-plate in the basement. A qualified licensed electrical contractor should correct as needed.

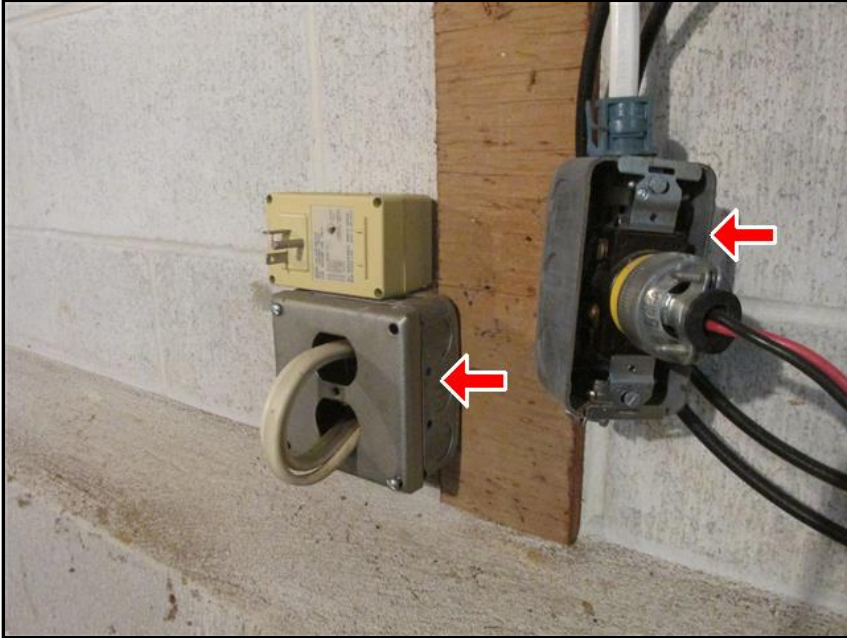
7.3 Item 5(Picture) Amateur basement wiring.

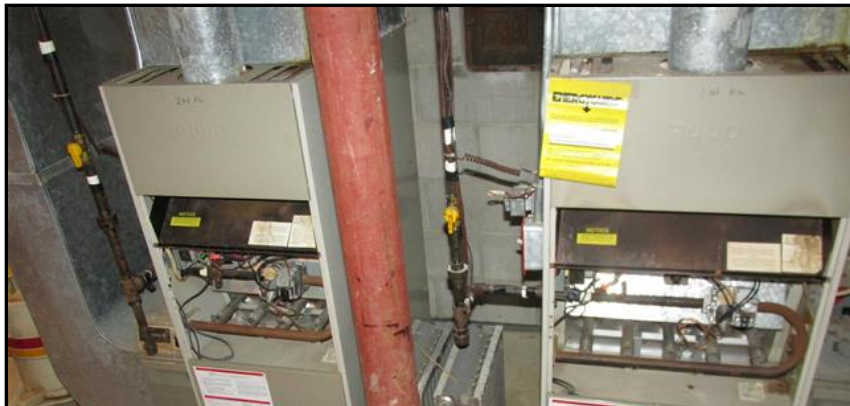
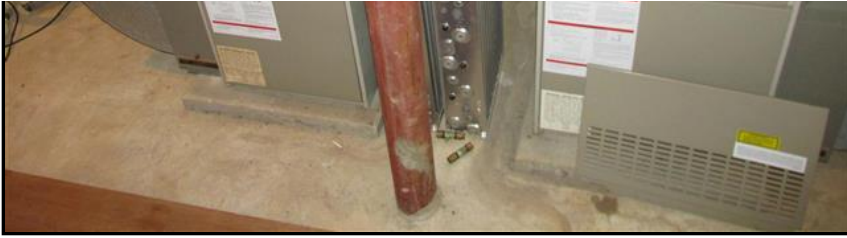
8.0 Item 1(Picture) Aged furnaces.

8.0 The furnaces aged and at the end of their life expectancy but did work at time of inspection. I am unable to determine life remaining.

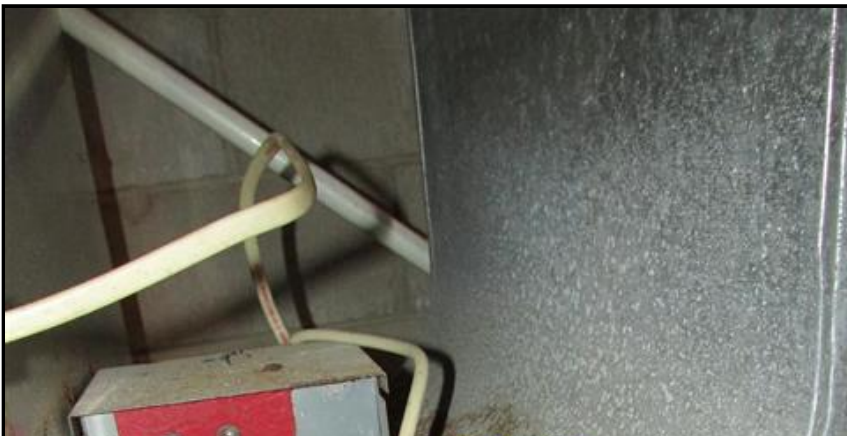
8.3 Item 1(Picture) Open wiring at removed electric air cleaner.

8.3 The one electronic air cleaner did operate properly at time of inspection. The other electric air cleaner is disconnected and wires are exposed. Repairs are needed. Electronic air cleaners are expensive and further inspection by a licensed HVAC person is recommended.

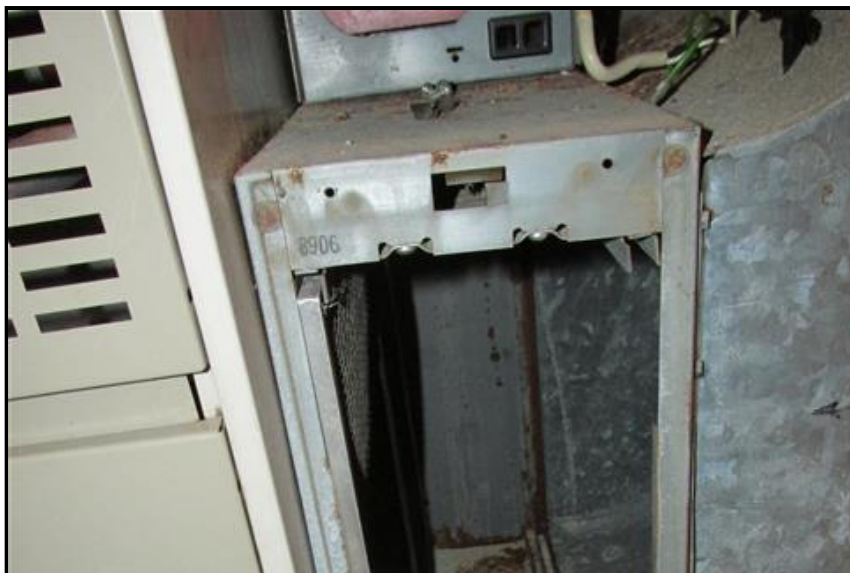
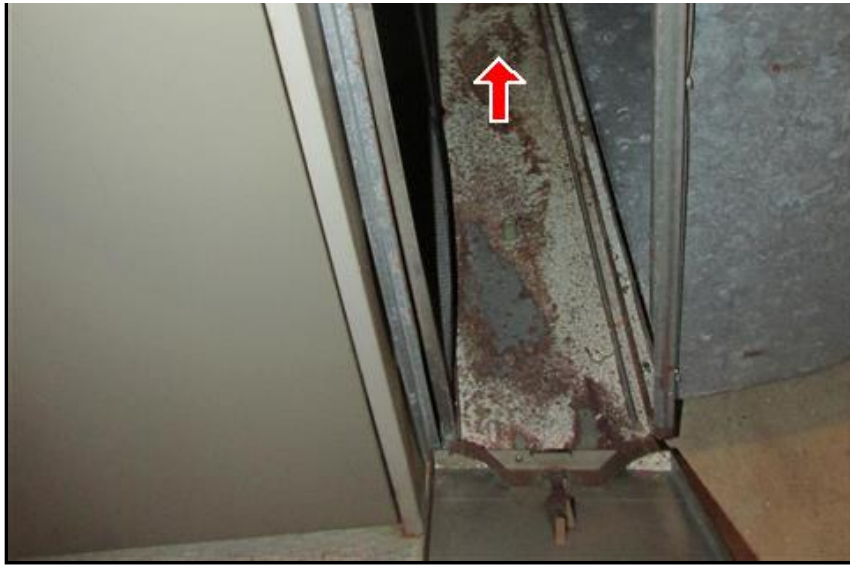
8.3 Item 2(Picture) Missing air filters.

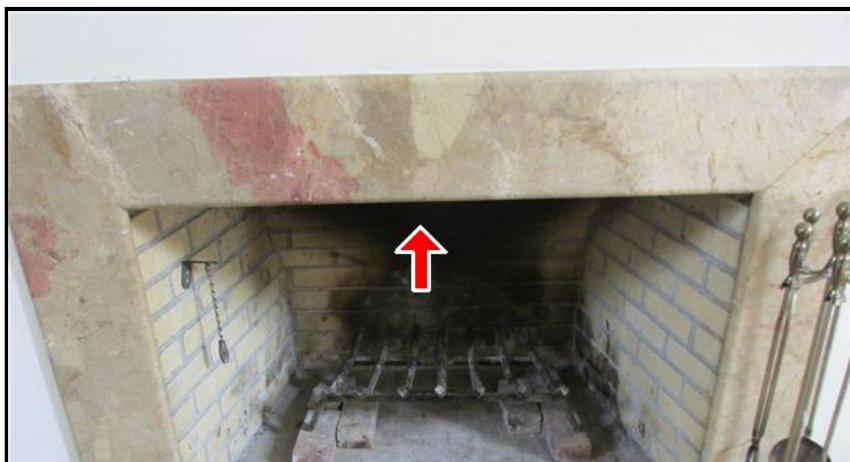
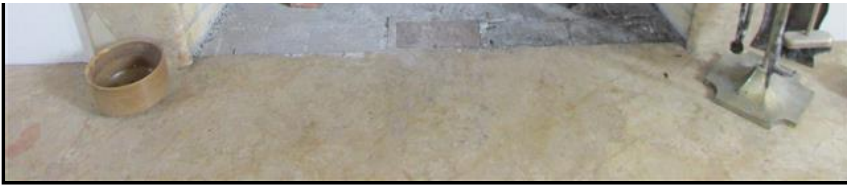
8.5 Item 1(Picture) Chimney sweep needed.

8.5 The liner was mainly visible and appears good except for creosote dust that may conceal a hairline crack until cleaned and inspected by a licensed chimney sweep. For a detailed inspection of liner, I recommend a qualified chimney sweep inspect for safety.
