# Inspection Report

**Property Address:**  
1708 Merriam Dr.  
Bridgewater NJ 08807

## Garden State Home Inspectors, LLC

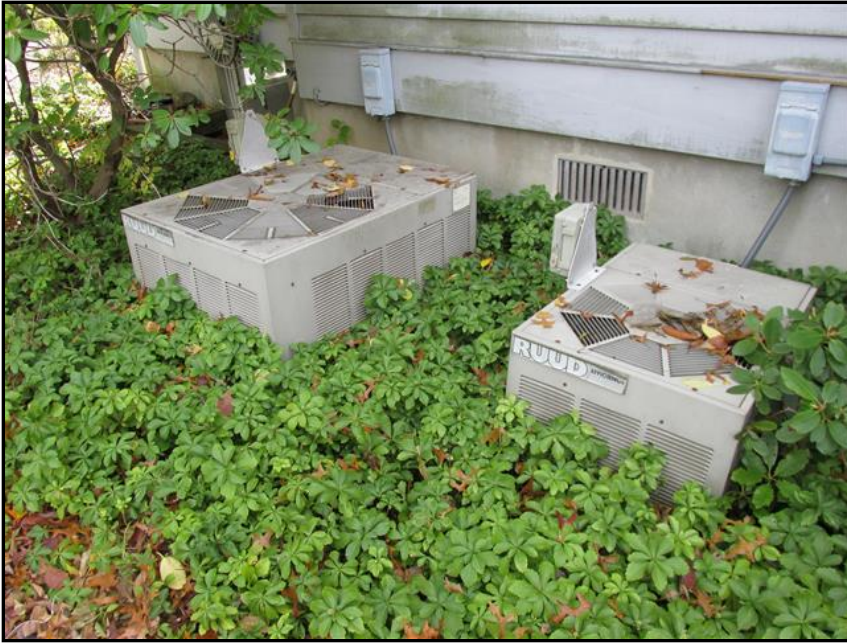
8.8 (1) The condenser outside (AC units) are aged and at the end of their life expectancy. I cannot determine how long your AC will last before a replacement is necessary. There is heavy vegetation growth that needs removal so A/C units get proper air flow.

8.8 Item 1(Picture) Aged A/C units. Not tested.

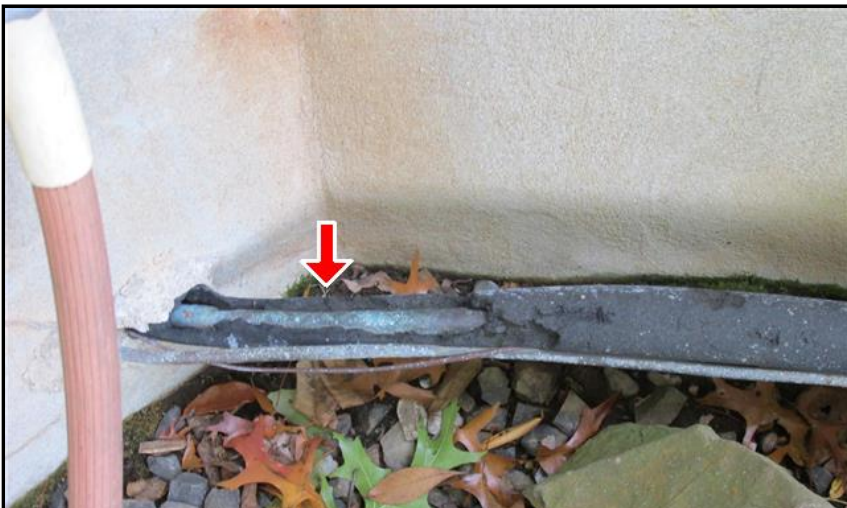
**8.8 Item 2(Picture) A/C suction line needs insulation sleeve.**

(3) The foam sleeve on suction line is missing foam sleeve in area(s) at outside unit. Missing foam on suction line can cause energy loss and condensation. I recommend service or repair as needed.

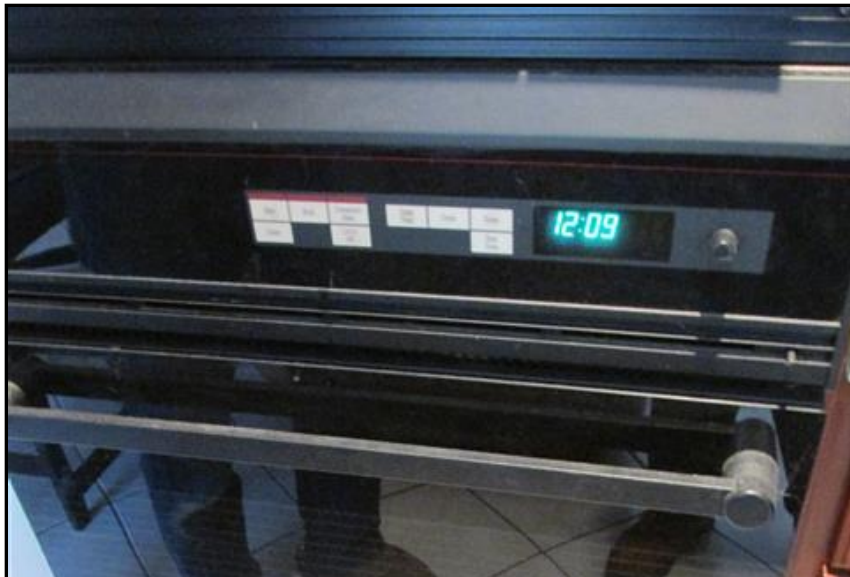
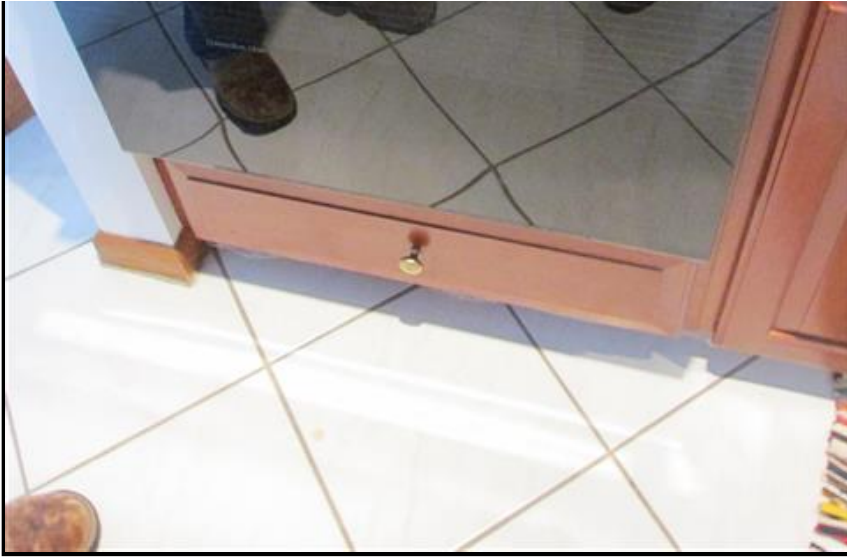
10.1 (1) The bay element for oven did not work when tested. I recommend repair as needed.

10.1 Item 1(Picture) Oven did not work properly at time of inspection.

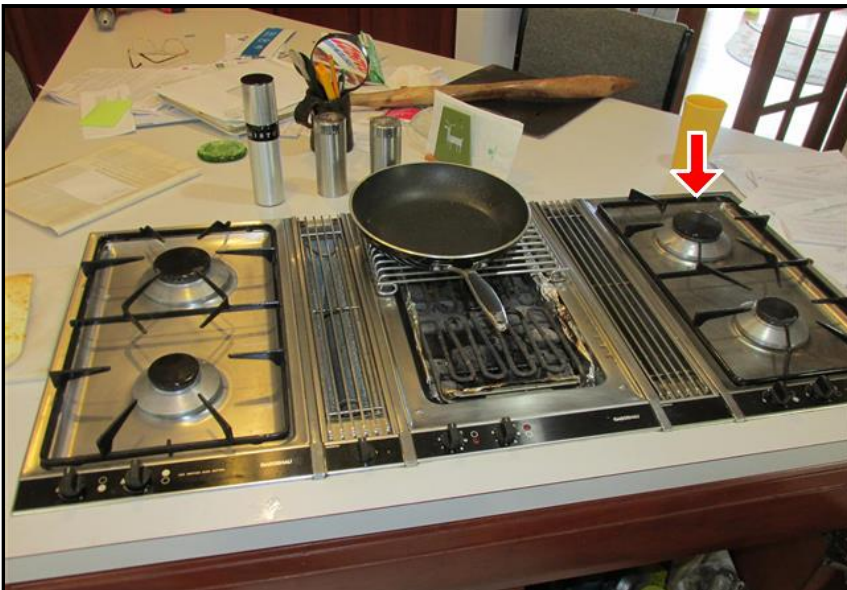
(2) The right rear burner (on cook top) did not work when tested. I recommend repair as needed.

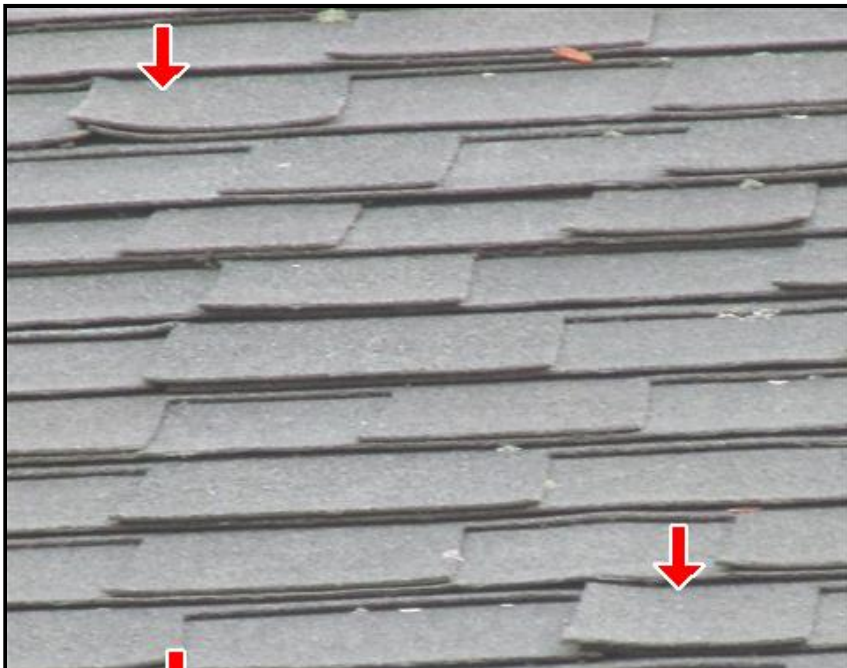
The roof covering is failing and is nearing the end of its life cycle at the "entire roof". Roof covering will need replacing before 5 years. A qualified contractor should inspect and repair as needed.

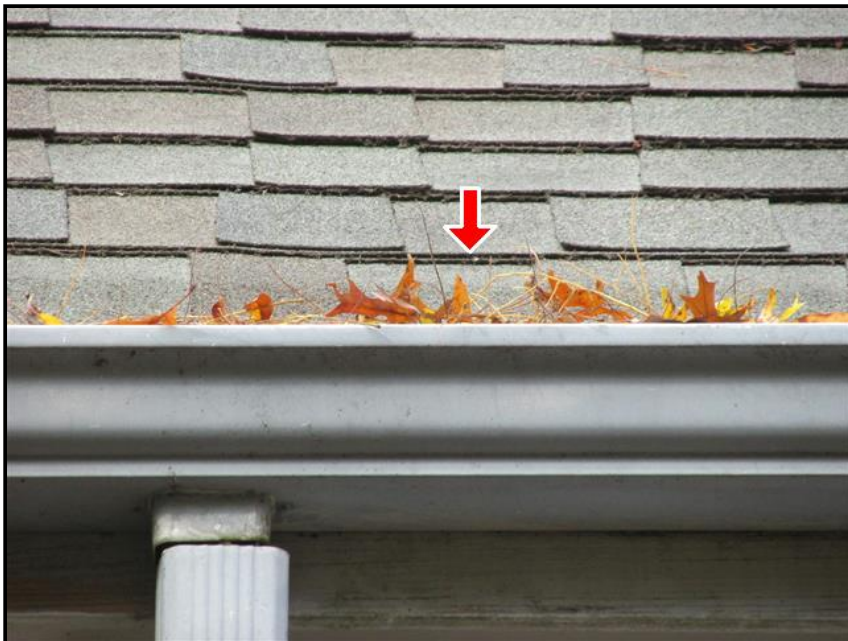
(1) The gutters are full of debris in areas and needs to be cleaned. The debris in gutters can also conceal rust, deterioration or leaks that are not visible until cleaned, and I am unable to determine if such conditions exist.

1.3 Item 1(Picture) Gutters need cleaning.

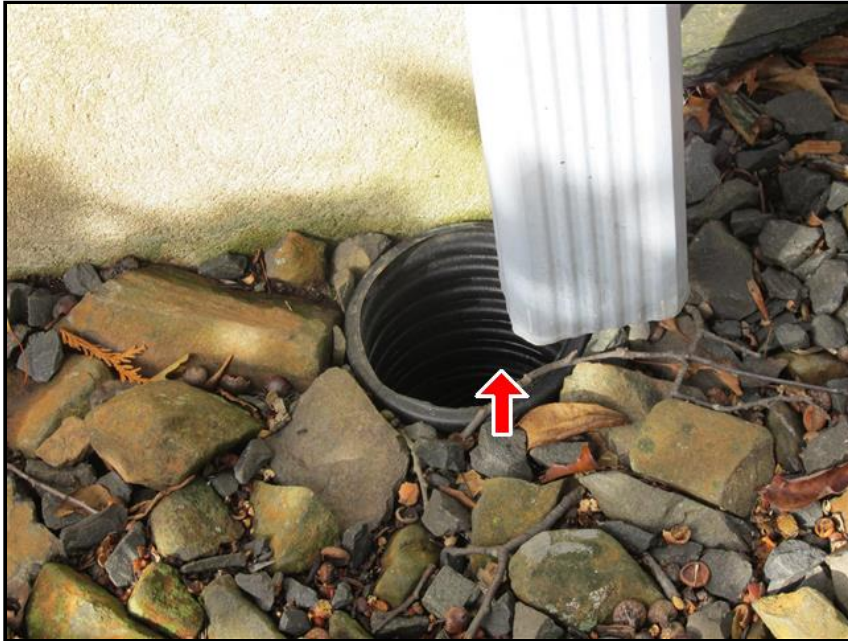
(2) The downspout needs reconnecting to existing drain line at most underground pipe connections. Erosion can continue or become worse if not corrected. A qualified person should repair or replace as needed.

1.3 Item 2(Picture) Downspout connection repairs needed.

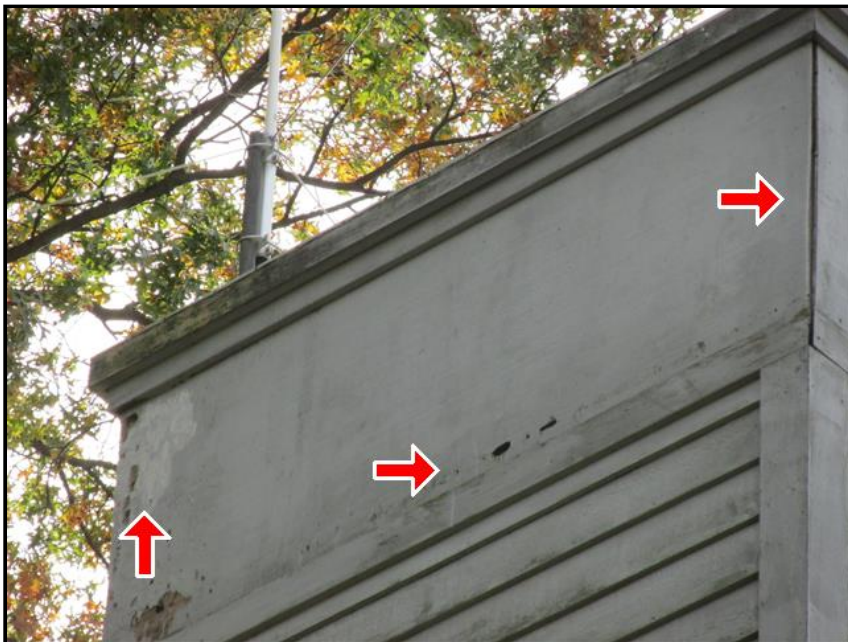
(1) The Wood siding at the exterior in areas has peeling paint or failing. Deterioration can eventually occur if not corrected. I recommend prep and paint using a qualified contractor.

2.0 Item 1(Picture) Loose, damaged siding.

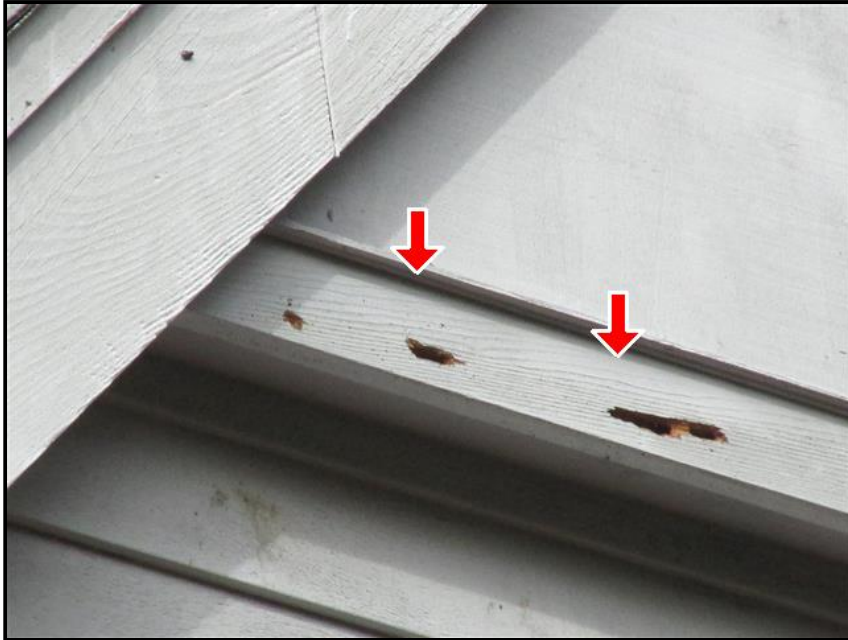
(2) The Wood trim at the exterior in areas is damaged and has peeling paint or failing. Further deterioration can occur if not corrected. A qualified contractor should inspect and repair as needed.

2.0 Item 2(Picture) Damaged trim work.

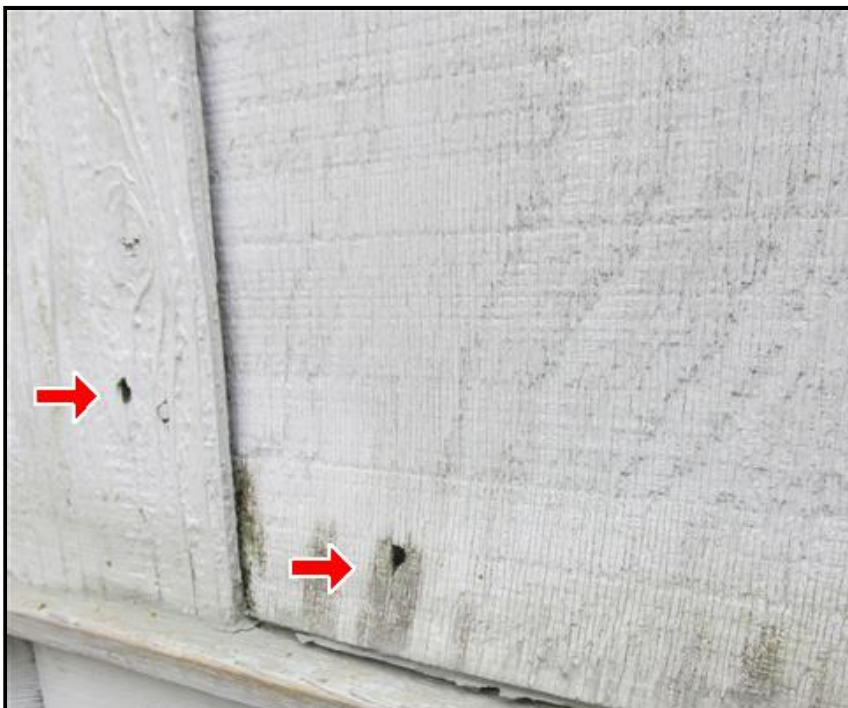
(3) The Wood siding at the exterior in areas has lifted nails and needs tightened. Further warping of siding can occur if loose nails are not tightened. A qualified contractor should inspect and repair as needed.

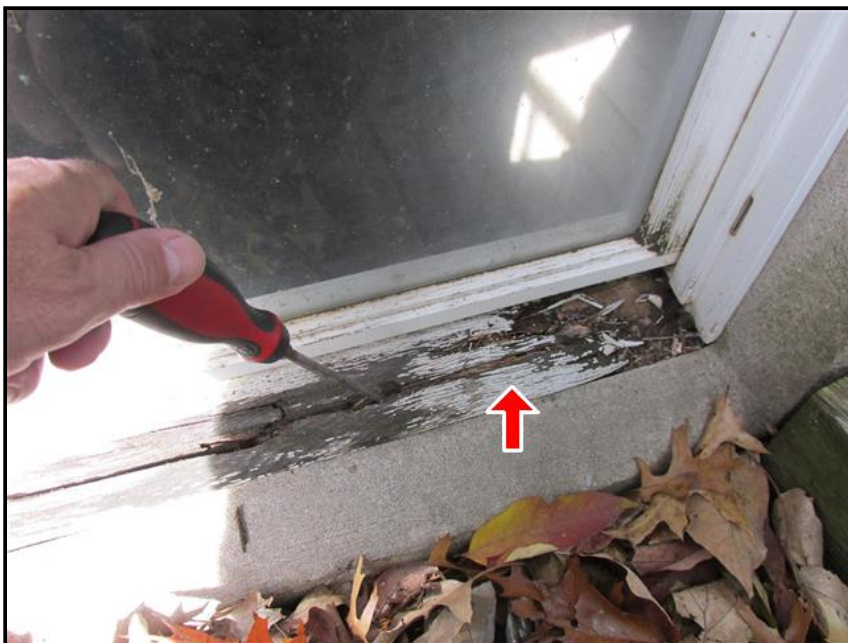
The basement window frame is insect and water damaged and deteriorated at right side (facing front). Further deterioration may occur if not repaired. A qualified contractor should inspect and repair as needed.

2.2 Item 1(Picture) Deteriorated basement window frame.

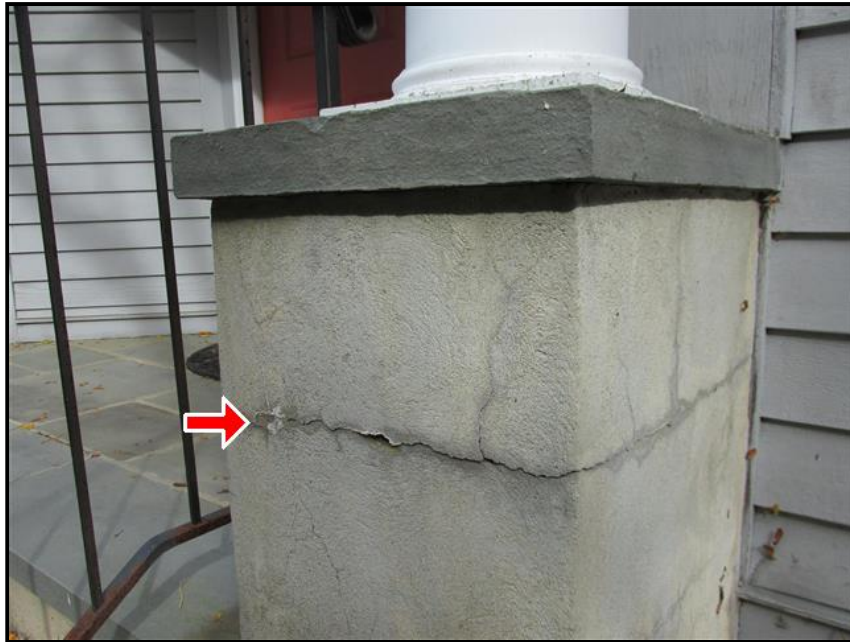
(1) The stone steps and porch at the front of home needs mortar where loose or missing. Further deterioration can occur if not repaired. A qualified contractor should repair or replace as needed.

2.3 Item 1(Picture) Porch mortar repairs needed.

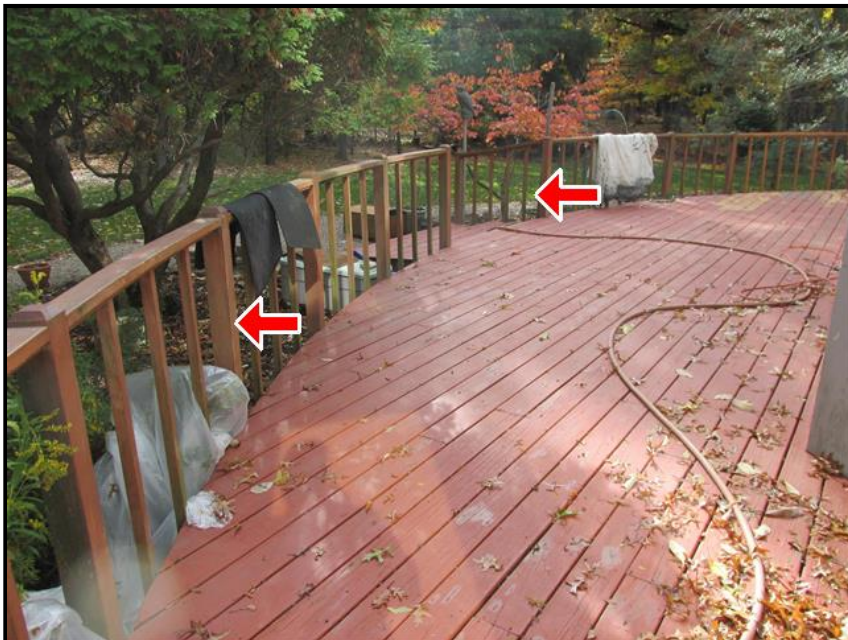
(2) The guardrails on deck at the rear of home and balcony at side of home are spaced to far apart for safety. Spacing more than 4 inches apart could allow an adult, child or pet to fall through. A qualified contractor should repair or replace as needed.

2.3 Item 3(Picture) Deck spindles spaced to far apart.

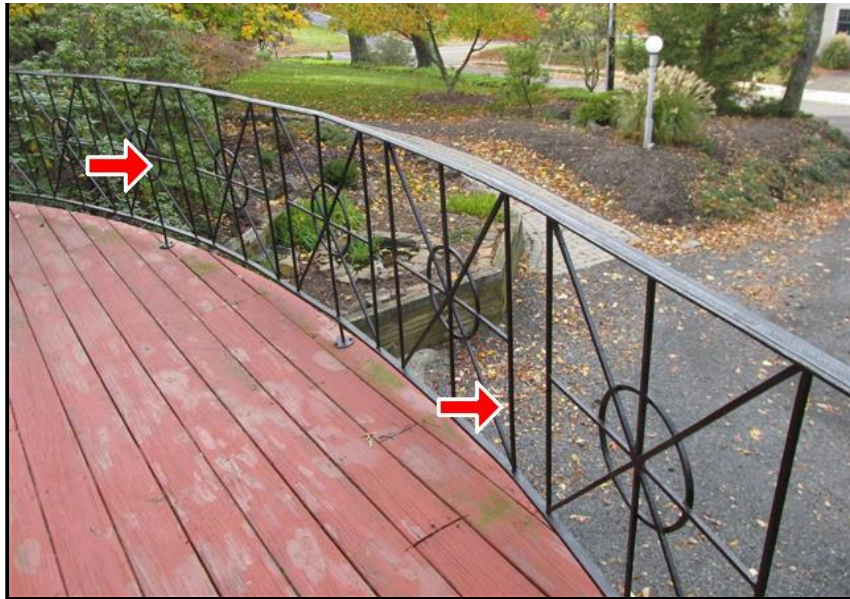
2.3 Item 4(Picture) Balcony railing balusters spaced to far apart.

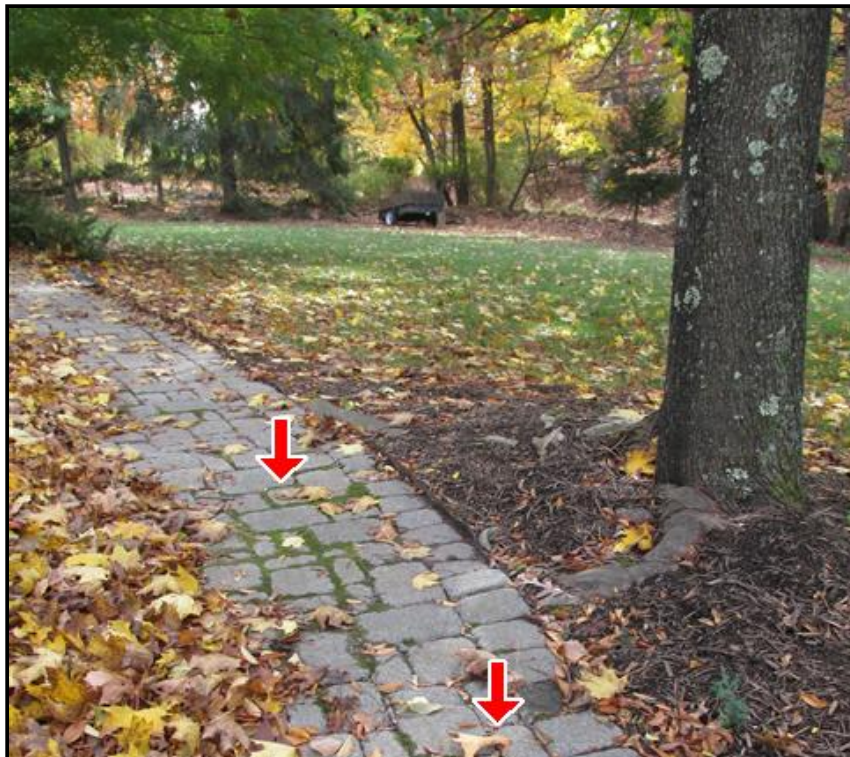
(1) The brick walkway at the front of home and left side (facing front) has dropped or settled causing a step or uneven step and shows signs of erosion and problem needs to be addressed. Water can cause further deterioration if not repaired and sealed properly. A qualified contractor should inspect and repair as needed.

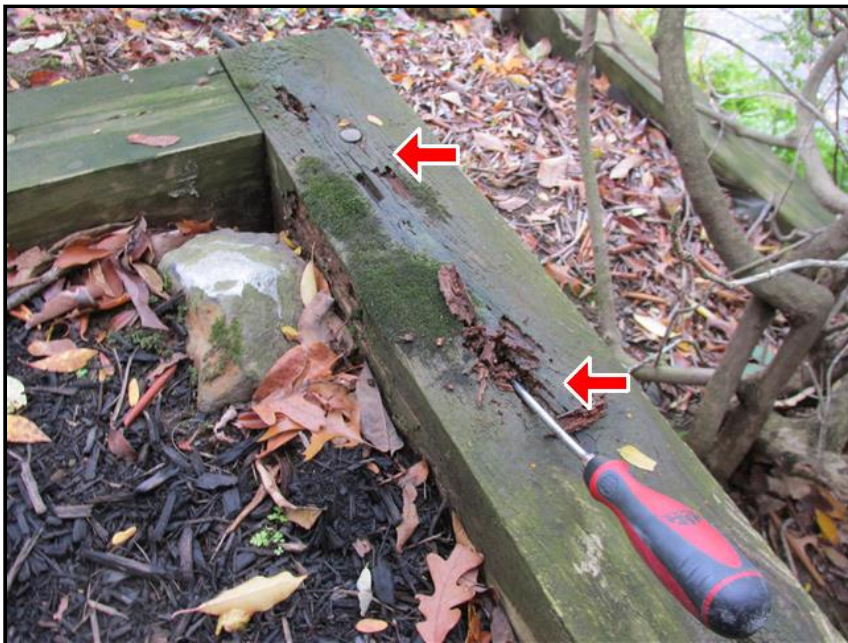
(2) The wood timber wall at the exterior areas shows signs of insect damage, erosion and a possible drainage problem. Further deterioration may occur if not repaired. A qualified contractor should repair or replace as needed.

2.4 Item 2(Picture) Damaged timber walls at small areas.

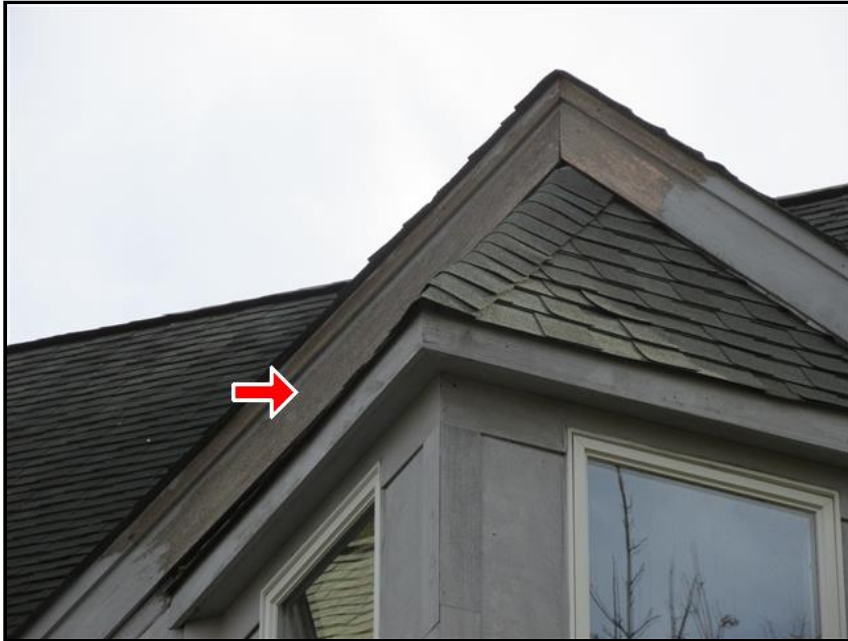
(1) The wood fascia at eave on the exterior in areas are damaged and has peeling paint. Further deterioration may occur if not repaired. A qualified contractor should inspect and repair as needed.

2.5 Item 1(Picture) Prep, prime and paint needed at exterior.

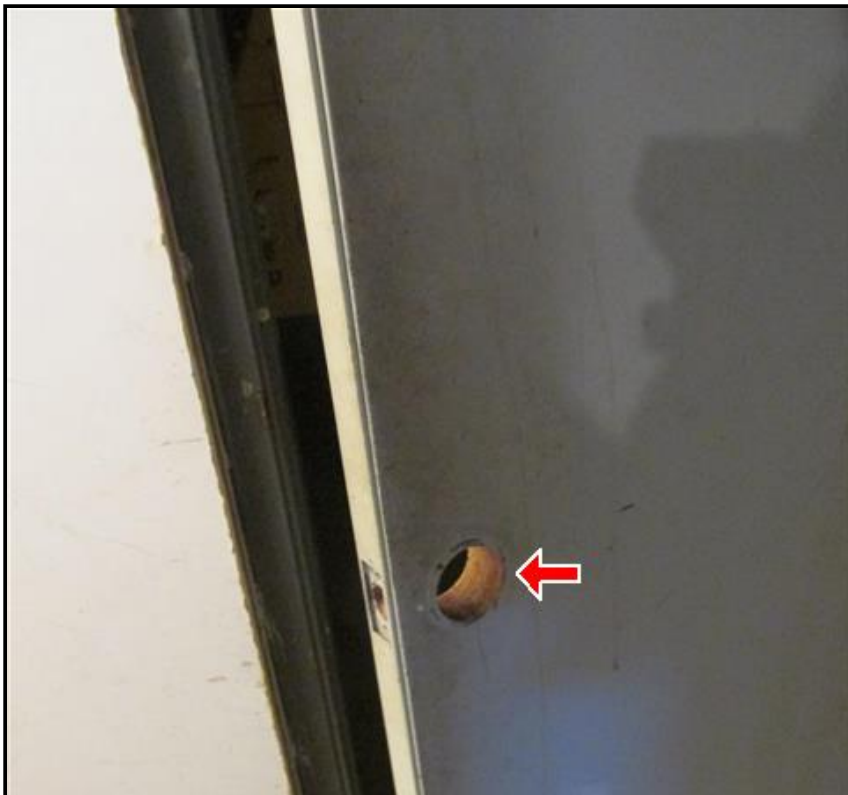
The knob and hardware is missing. I recommend install as needed.

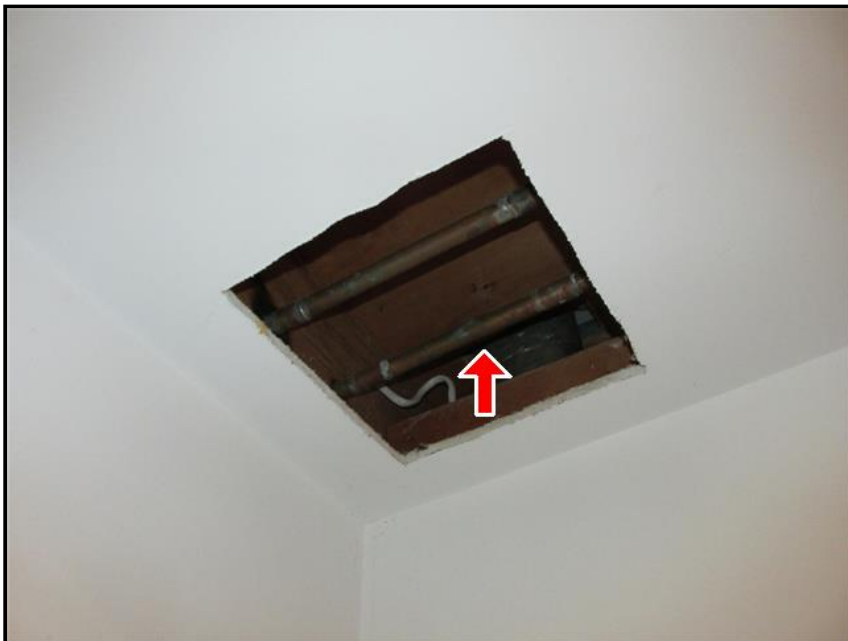
The Sheetrock on the ceiling is damaged at the downstairs Half 1/2 Bath. While this damage is cosmetic, it needs to be repaired. A qualified person should repair or replace as needed.

4.0 Item 1(Picture) Ceiling sheetrock repair needed.

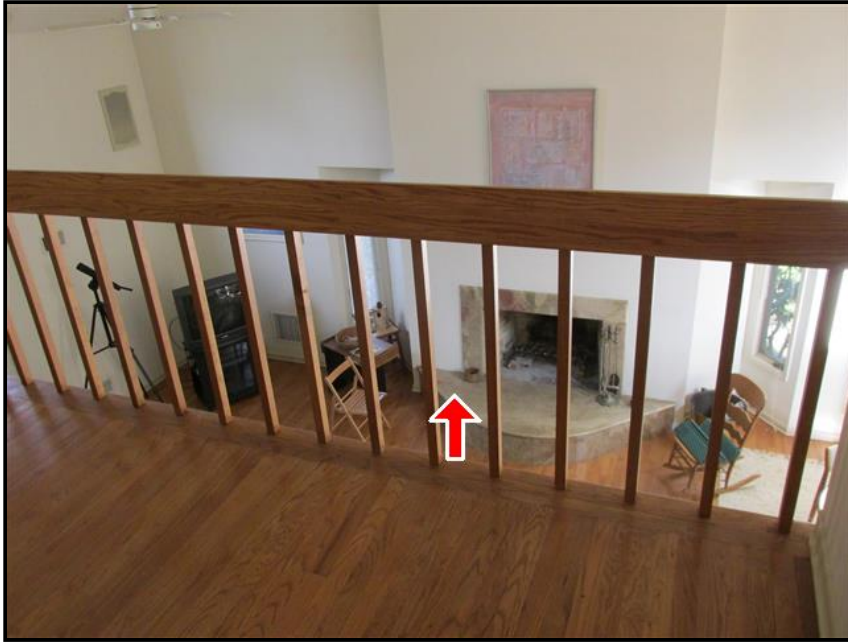
The balusters on the guard rail at the second story stairs are spaced to far apart for safety. Spacing more than 4 inches apart could allow an adult, child or pet to fall through. A qualified contractor should inspect and repair as needed.

4.3 Item 1(Picture) Spindles spaced to far apart.

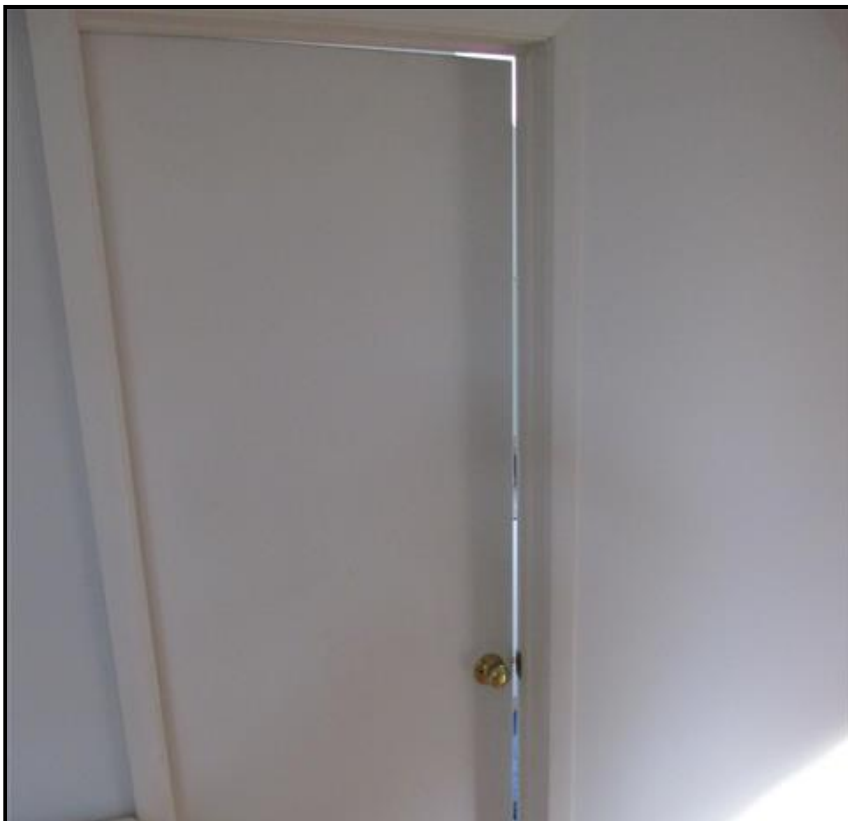
(1) The Entry door rubs floor when opened. Door needs to be trimmed at bottom by a skilled craftsman and does not lock at the Guest Bedroom Private Bath. A repair or replacement is needed. A qualified person should repair or replace as needed.

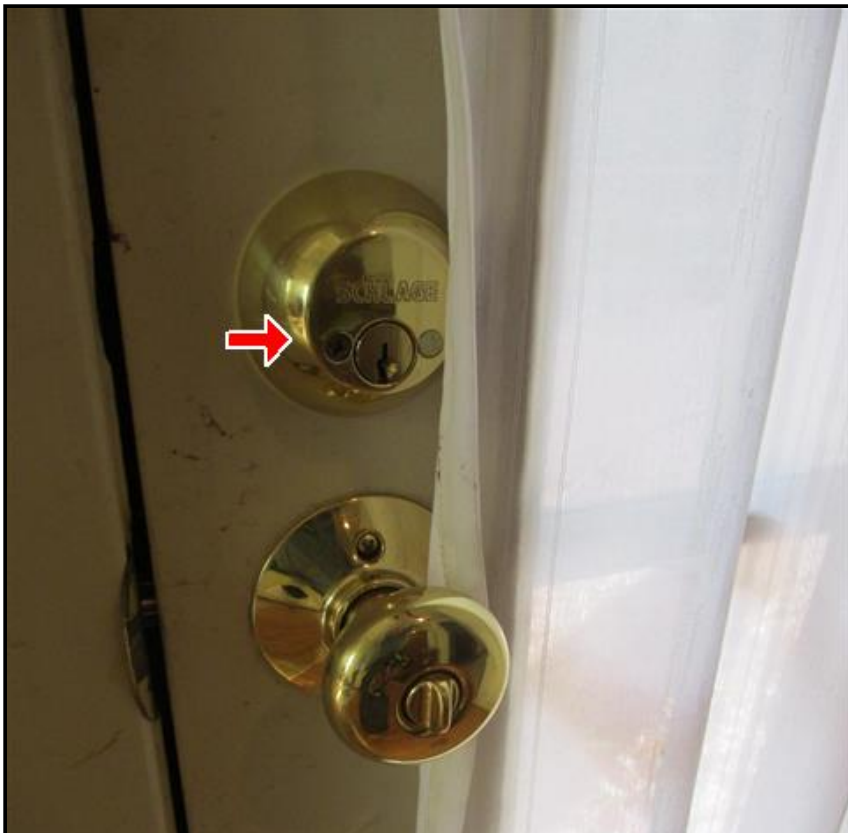
(2) Your home has keyed dead bolt door hardware. This style of hardware is considered a safety issue. I recommend installing knob style dead bolt lock hardware.

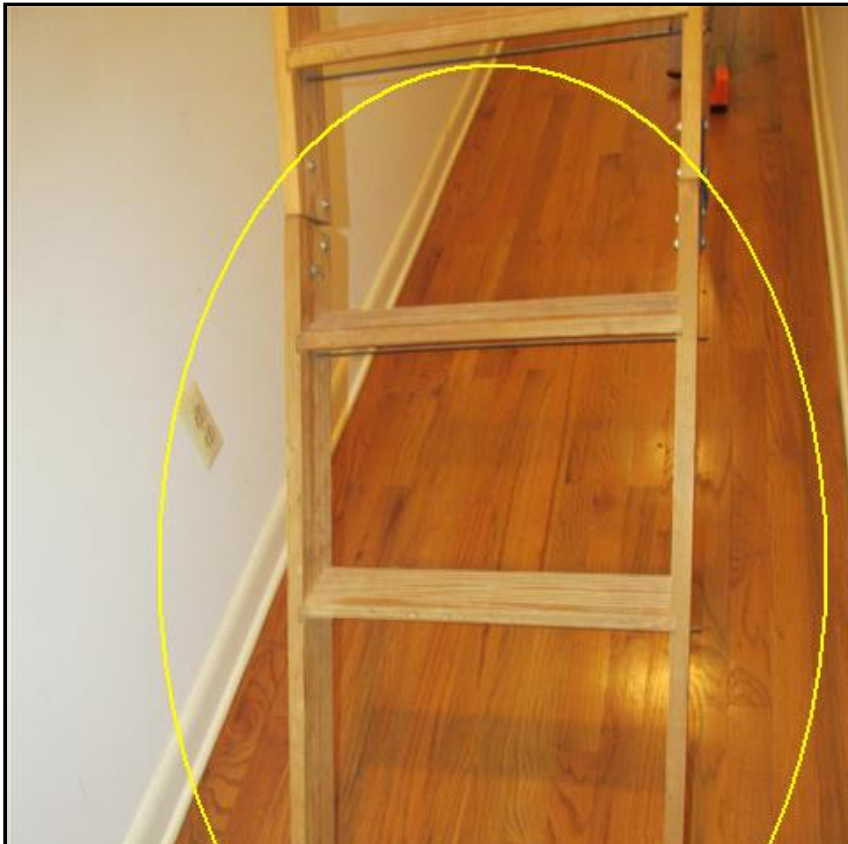
(1) The attic stairs is weak and not stable at or near bottom of stairs. Injury could result if not repaired. A qualified contractor should inspect and repair as needed.

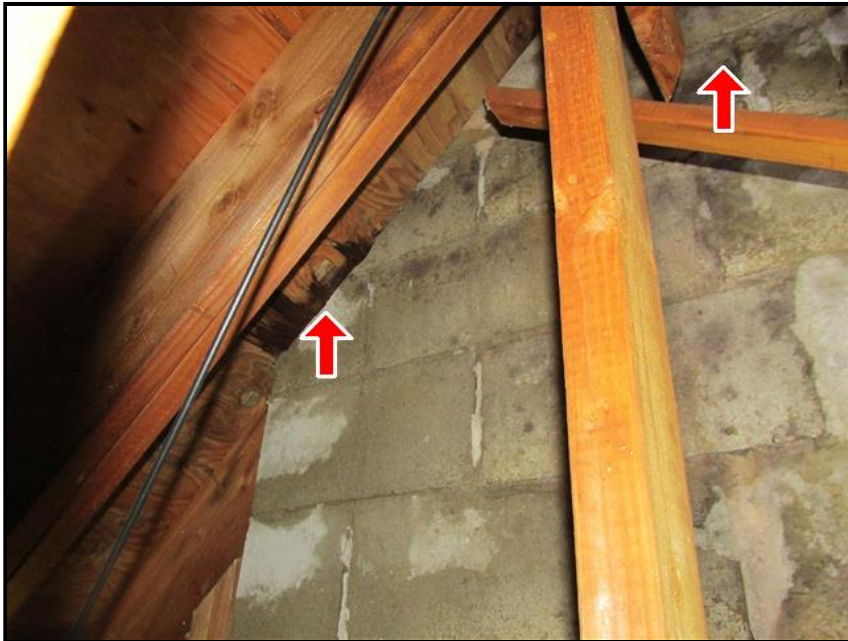
(2) The roof sheathing is somewhat deteriorated or soft at the chimney. Water intrusion signs are visible. Repairs are needed. I recommend qualified contractor inspect further and advise for repairs as needed.

5.5 Item 2(Picture) Water intrusion at sheathing around chimney.

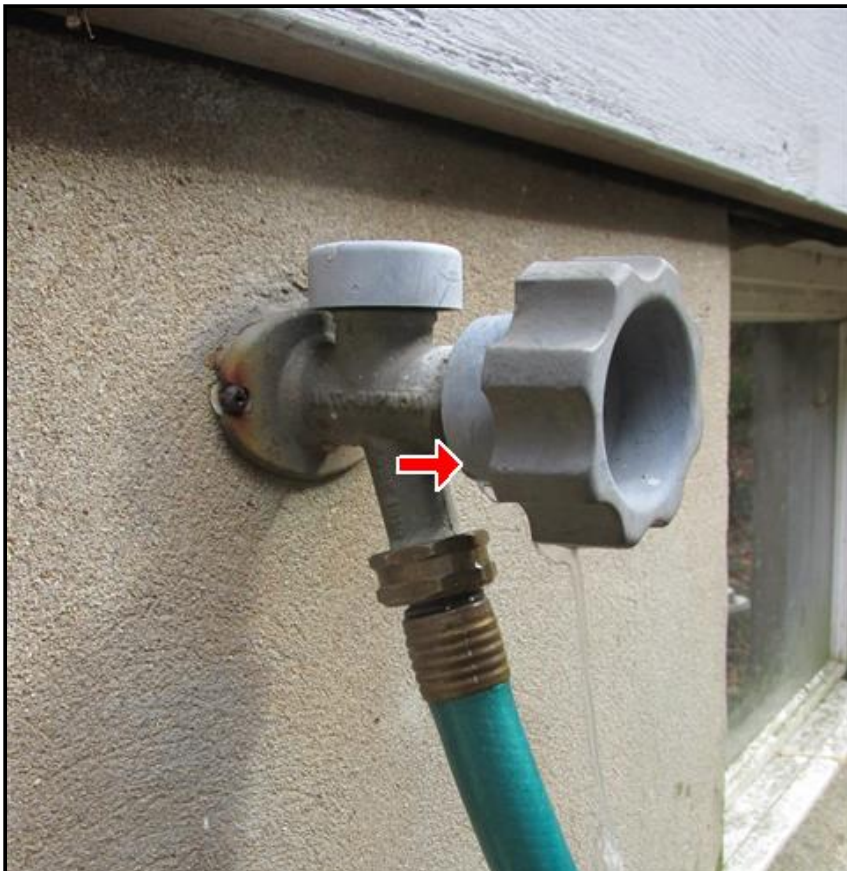
(1) The hose bib drips at knob when turned on at the front of home. Repairs are needed. A qualified licensed plumber should repair or correct as needed.

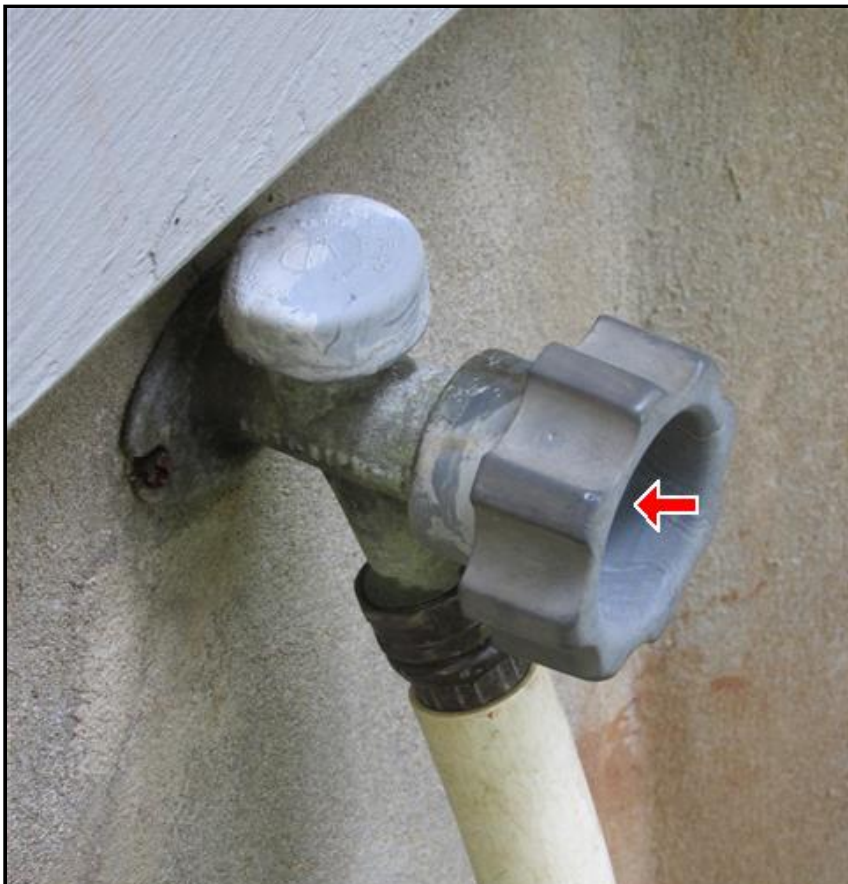
(2) The hose bib did not work at the rear of home. Repairs are needed. A qualified licensed plumber should repair or correct as needed.

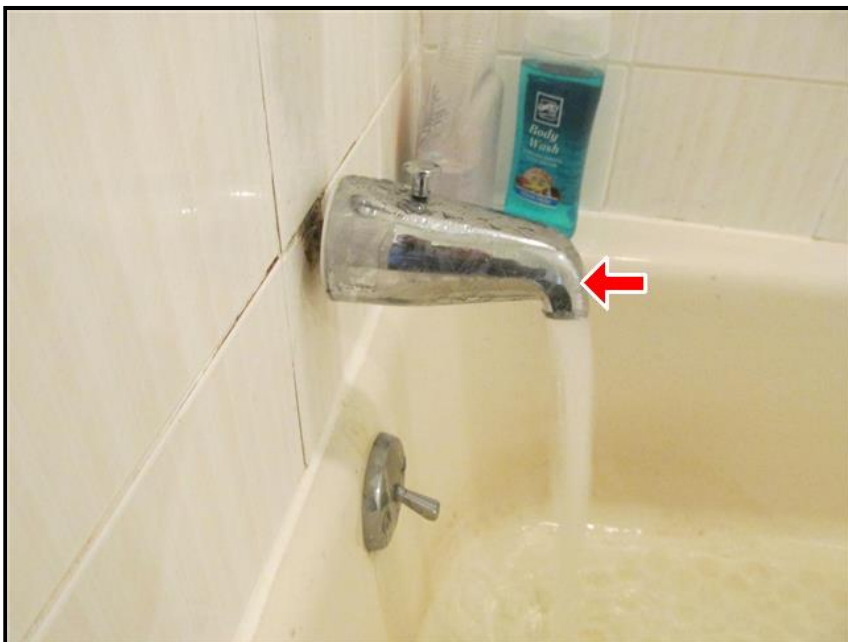
(3) The tub spout leaks at the hall bath. Repairs are needed. A qualified licensed plumber should repair or correct as needed.

6.1 Item 3(Picture) Spout diverter repairs needed.

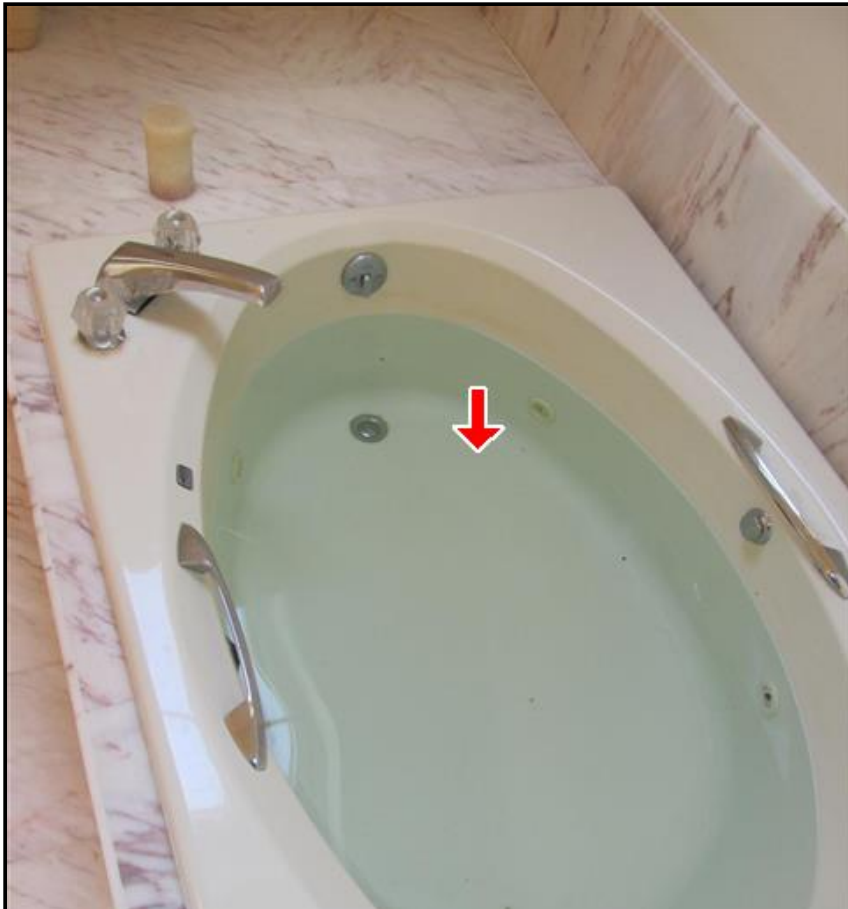
(4) The jet powered bath tub did not work properly at time of inspection. I recommend qualified contractor repair as needed.

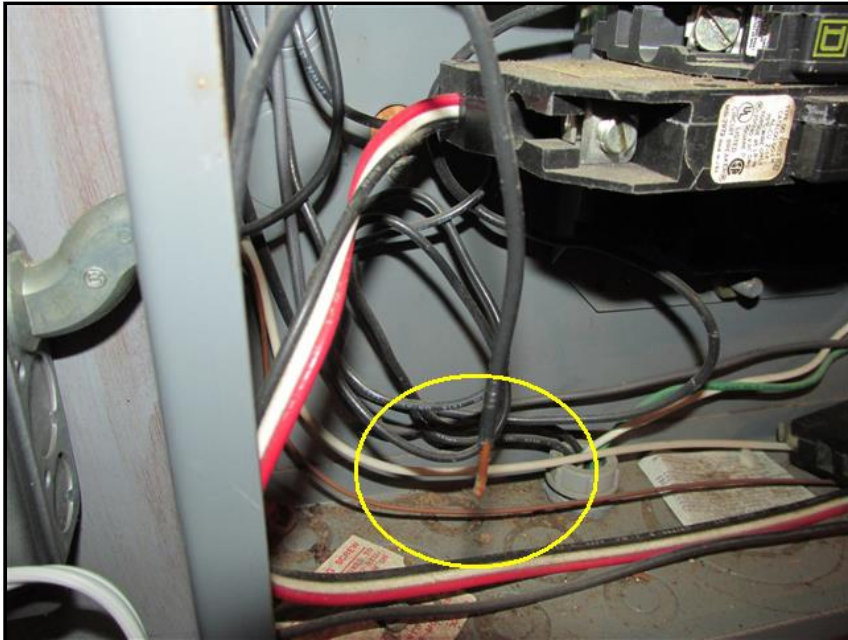
The problem(s) discovered in the panel such as amateur wiring installation, knock-outs missing on panel and any other problems that an electrical contractor may discover while performing repairs need correcting. I recommend a licensed electrical contractor inspect further and correct as needed.

7.1 Item 1(Picture) Open wiring inside electrical panel.

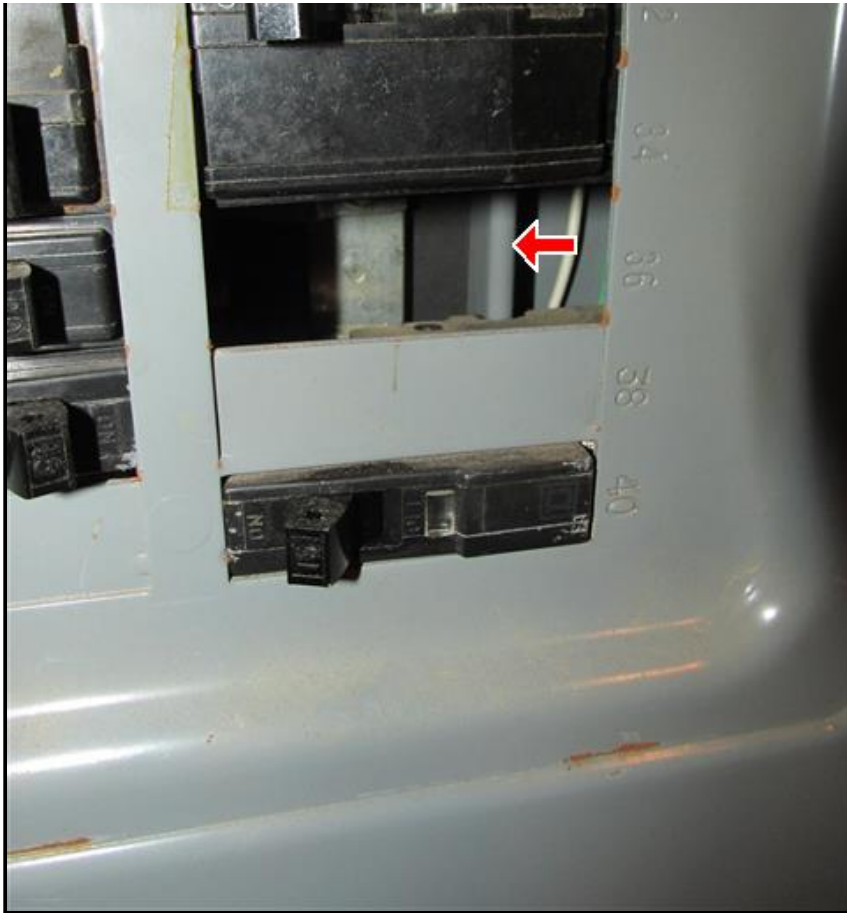
7.1 Item 2(Picture) Missing panel knock out covers.

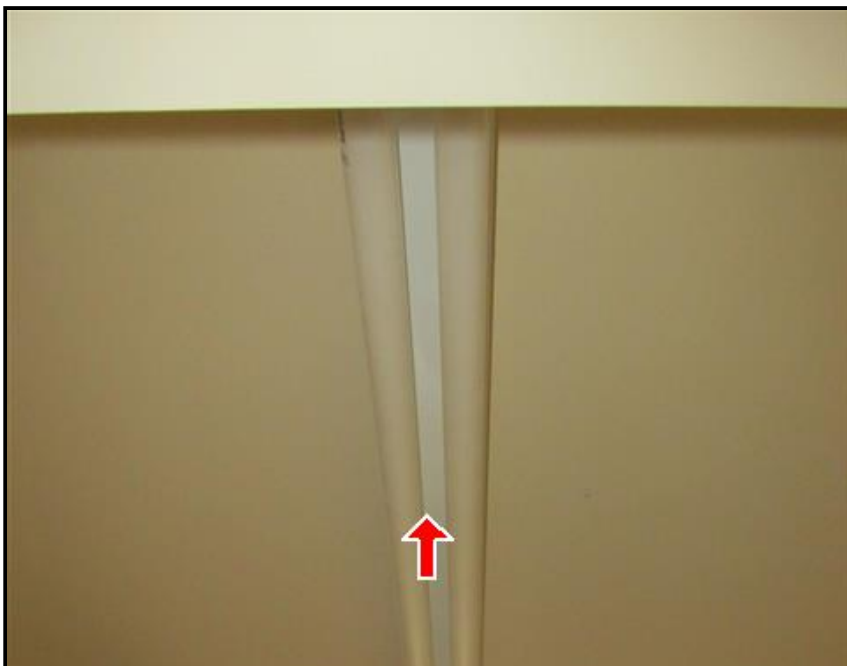
(1) The light fixture does work, but ballast is noisy at the Master Bedroom closet. Electrical issues are considered a hazard until repaired. A qualified licensed electrical contractor should correct as needed.

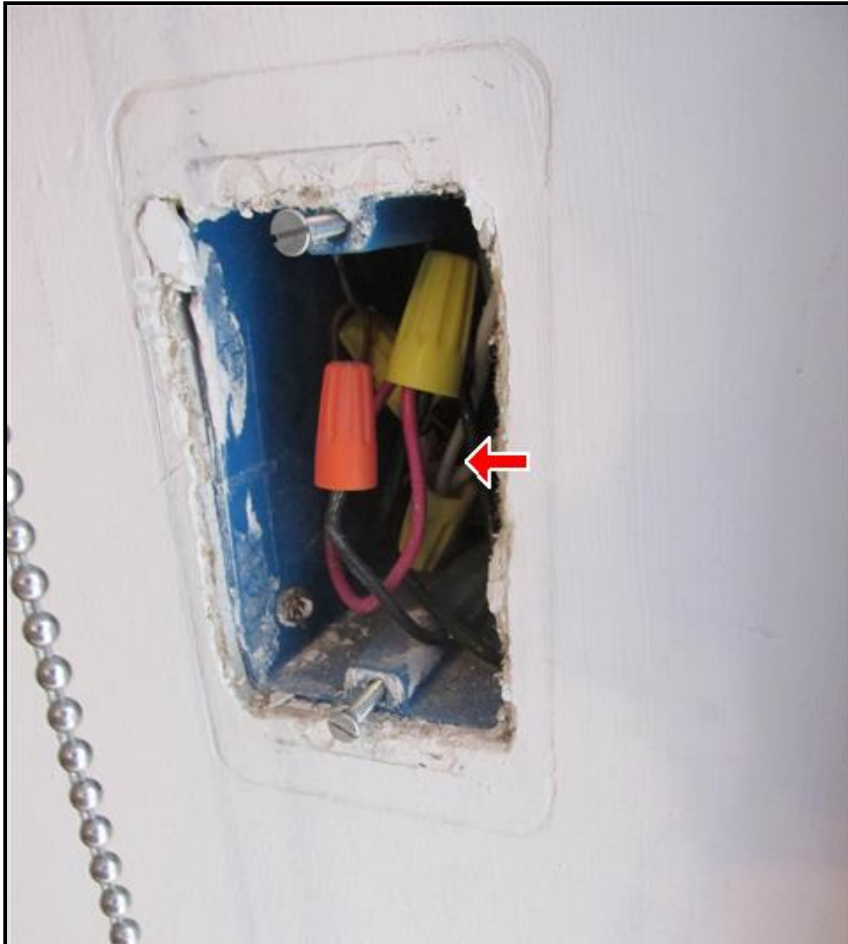
(2) The wall switch is missing at the Dining Room. Several other outlets and switch plates are missing. Electrical issues are considered a hazard until repaired. A qualified licensed electrical contractor should correct as needed.

7.3 Item 2(Picture) Missing wall switch.

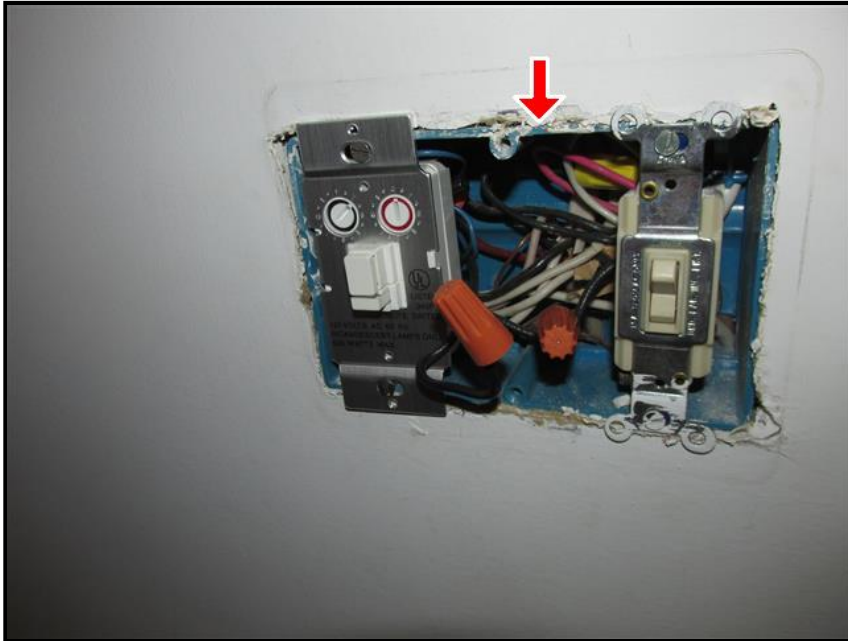
7.3 Item 3(Picture) Missing cover plates.

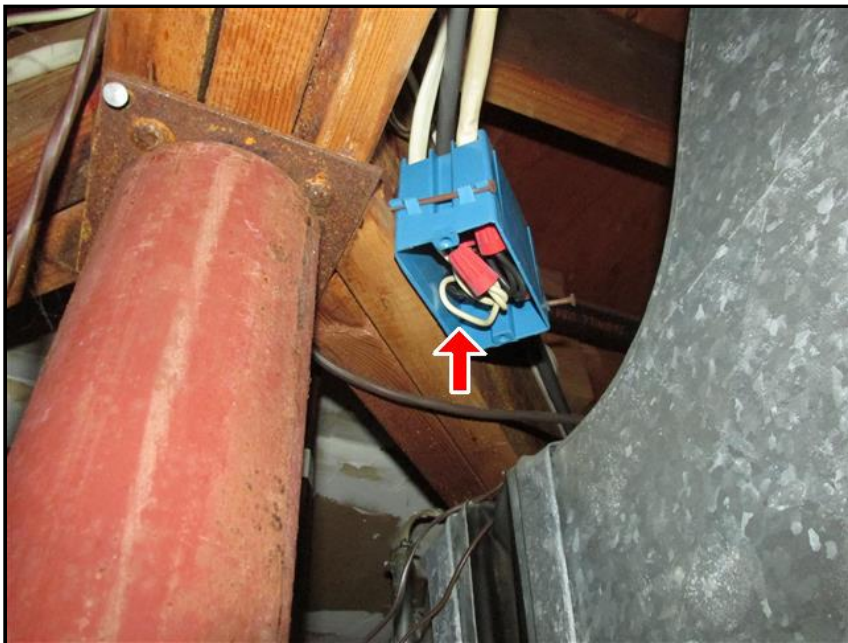
(3) Several junction boxes and open splices needs placing inside a box with a cover-plate in the basement. A qualified licensed electrical contractor should correct as needed.

7.3 Item 4(Picture) Missing cover plates.
