# Inspection Report

**Property Address:**  
1708 Merriam Dr.  
Bridgewater NJ 08807

## Garden State Home Inspectors, LLC

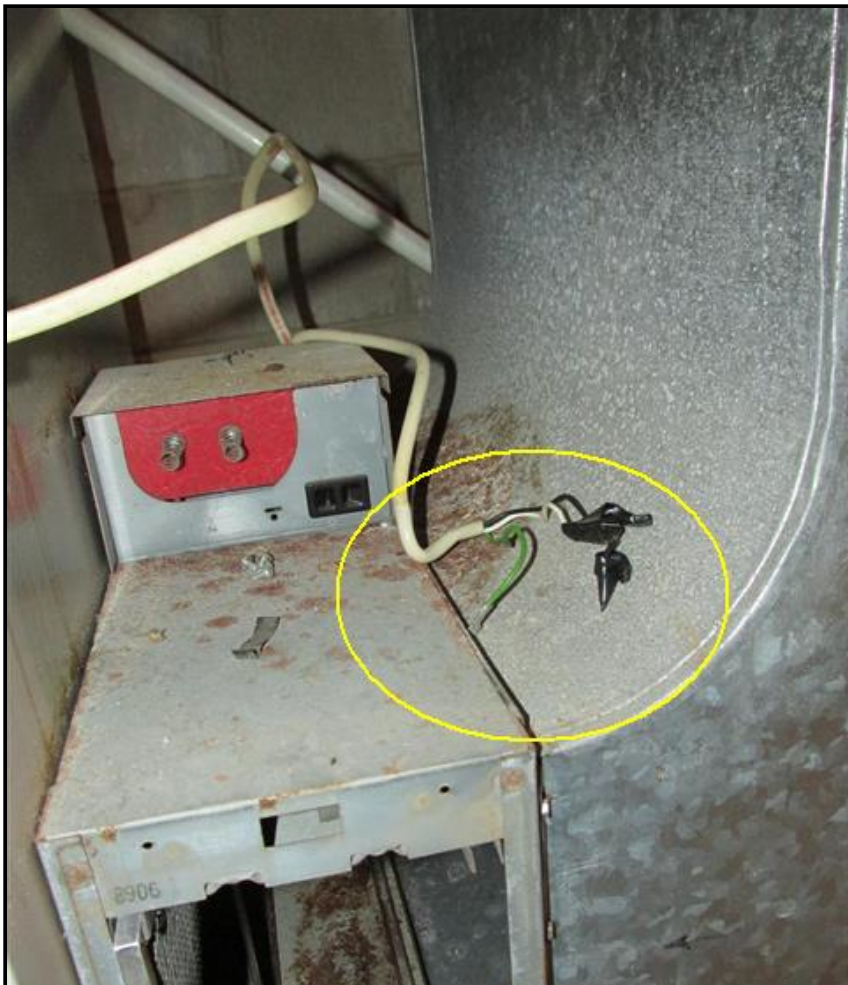
The one electronic air cleaner did operate properly at time of inspection. The other electric air cleaner is disconnected and wires are exposed. Repairs are needed. Electronic air cleaners are expensive and further inspection by a licensed HVAC person is recommended.

8.3 Item 1(Picture) Open wiring at removed electric air cleaner.

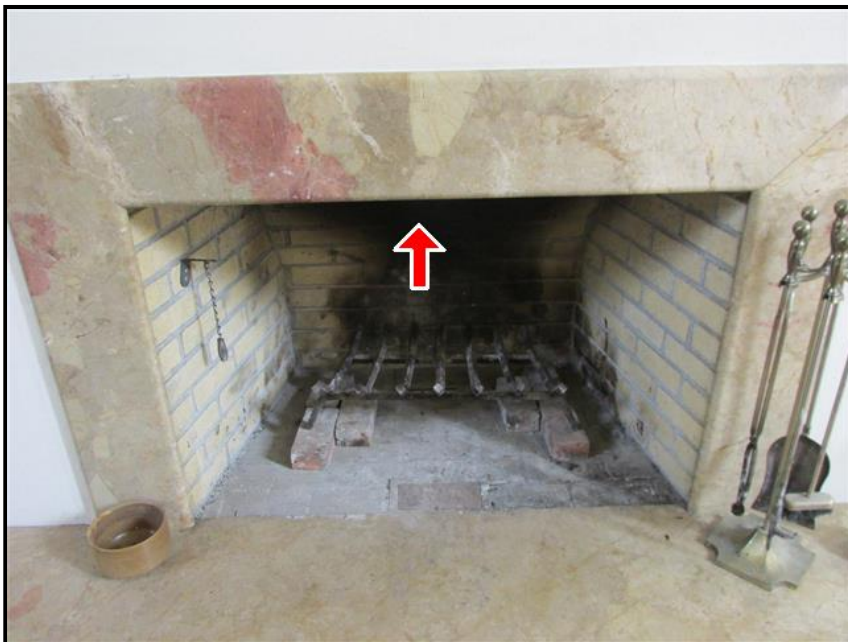
The liner was mainly visible and appears good except for creosote dust that may conceal a hairline crack until cleaned and inspected by a licensed chimney sweep. For a detailed inspection of liner, I recommend a qualified chimney sweep inspect for safety.

8.5 Item 1(Picture) Chimney sweep needed.

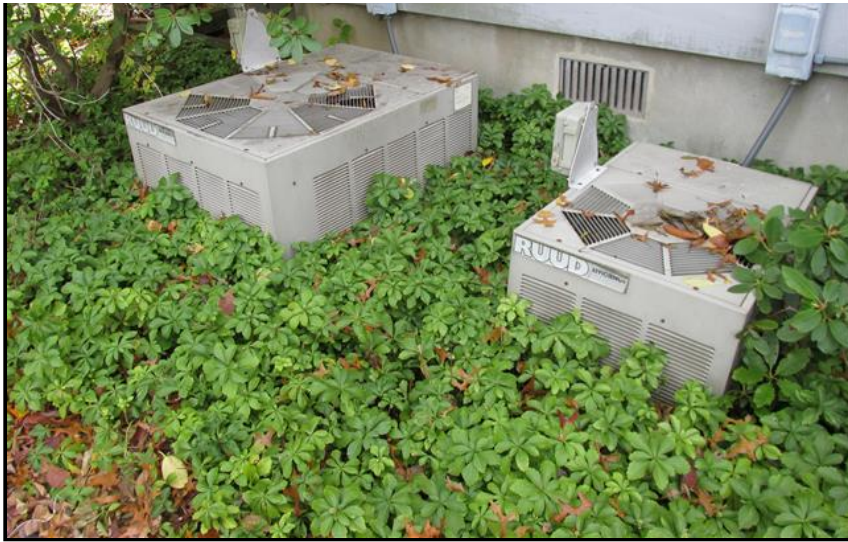
8.8 Item 1(Picture) Aged A/C units. Not tested.

(1) The condenser outside (AC units) are aged and at the end of their life expectancy. I cannot determine how long your AC will last before a replacement is necessary. There is heavy vegetation growth that needs removal so A/C units get proper air flow.

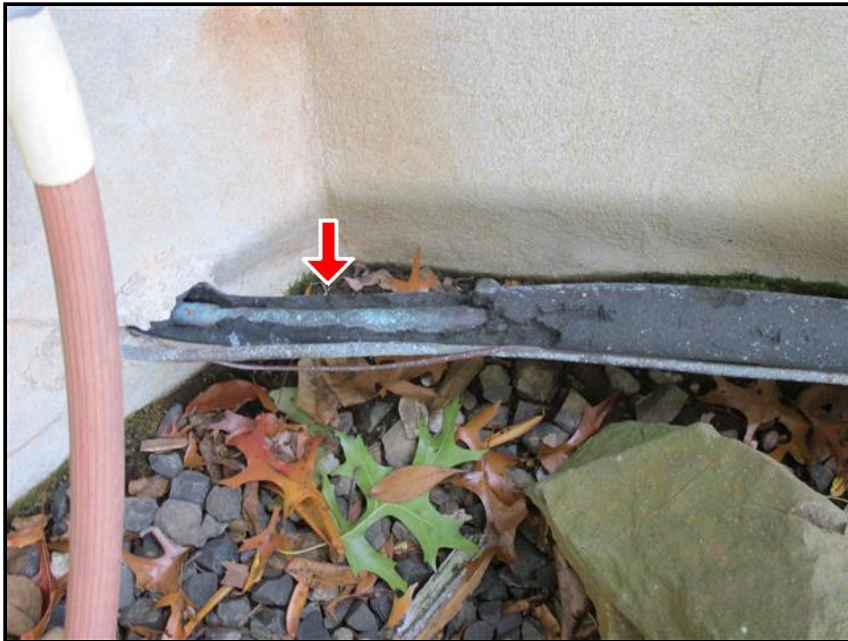
(3) The foam sleeve on suction line is missing foam sleeve in area(s) at outside unit. Missing foam on suction line can cause energy loss and condensation. I recommend service or repair as needed.

8.8 Item 2(Picture) A/C suction line needs insulation sleeve.

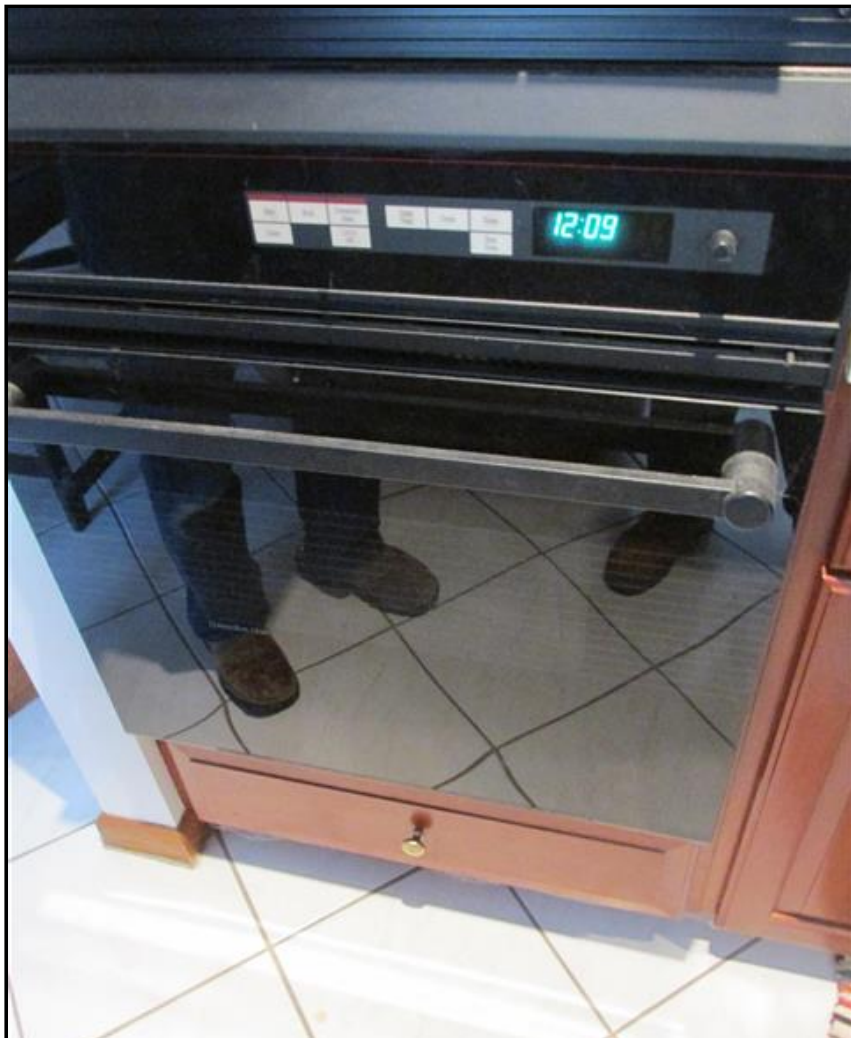
(1) The bay element for oven did not work when tested. I recommend repair as needed.

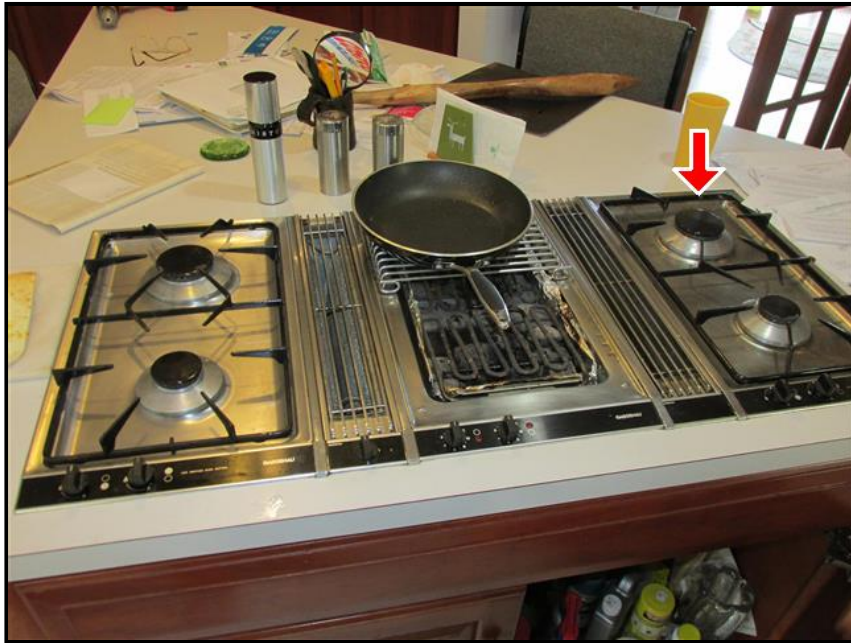
(2) The right rear burner (on cook top) did not work when tested. I recommend repair as needed.

10.1 Item 2(Picture) Rear burner not working.
